# Evaluating pedestrian safety at signalized intersections in San José, Costa Rica

Rebecca Peterniak, B.SC., EIT  
Jeannette Montufar, Ph.D., P.Eng,  
PTOE, FITE

*Department of Civil Engineering  
University of Manitoba*

June 3, 2014

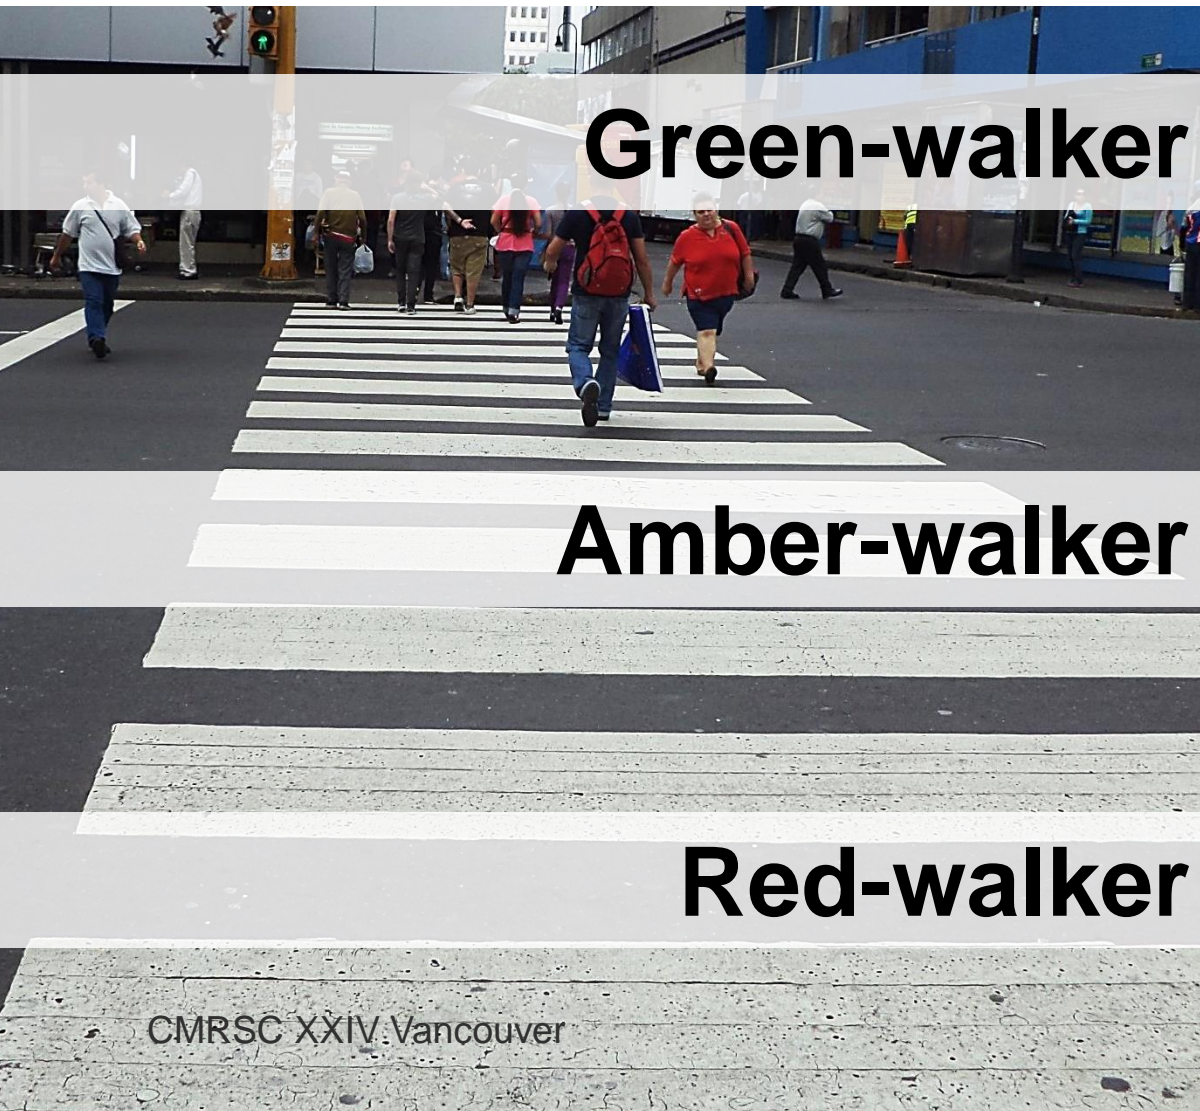
**Green-walker**

**Amber-walker**

**Red-walker**

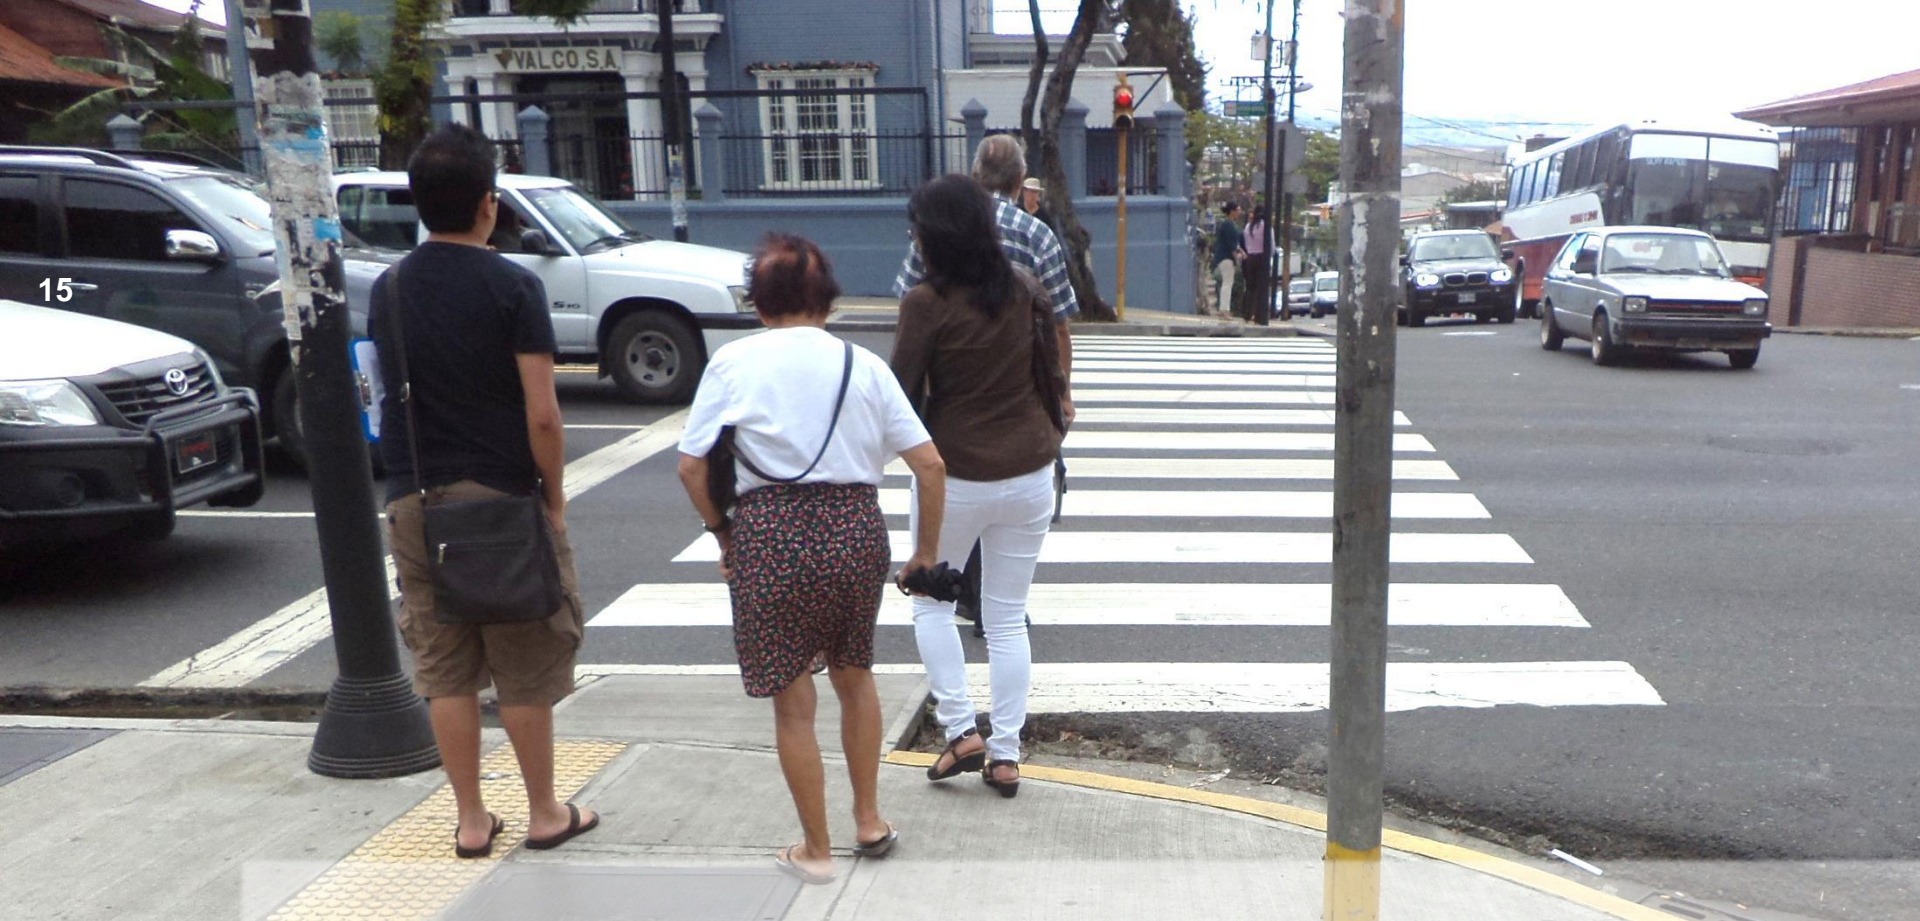
**Most conflicts occurred while the  
DON'T WALK interval was displayed**

- Developed and applied methodology for evaluating pedestrian safety using surrogate measures
- Intersection with the poorest signal compliance observed less than half of crossing pedestrians green-walking
- Most conflicts occurred during the DON'T WALK interval
