The Impact of Seatback Loading in Frontal Collisions

James Roos¹, Dr. Michael J. Shkrum^{1,2}, and Kevin McClafferty³

¹ Department of Pathology and Laboratory Medicine, Schulich School of Medicine and Dentistry, Western University

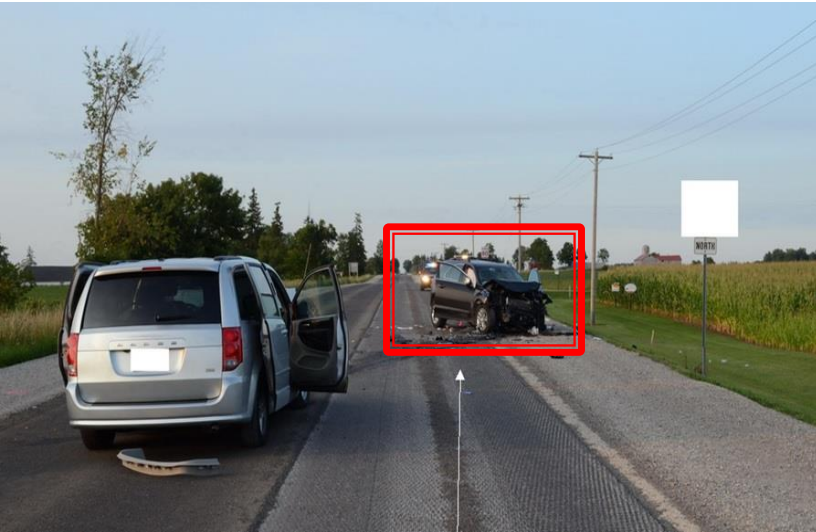
Collision Event

- Frontal collision
(Head-On in northbound lane)
- Aversive reaction of non-case vehicle
- SUV (case vehicle) skidded 7m south
(final position: east edge of northbound lane, facing southeast)
- Non-case vehicle propelled rearwards
(final position: southbound lane, facing north)

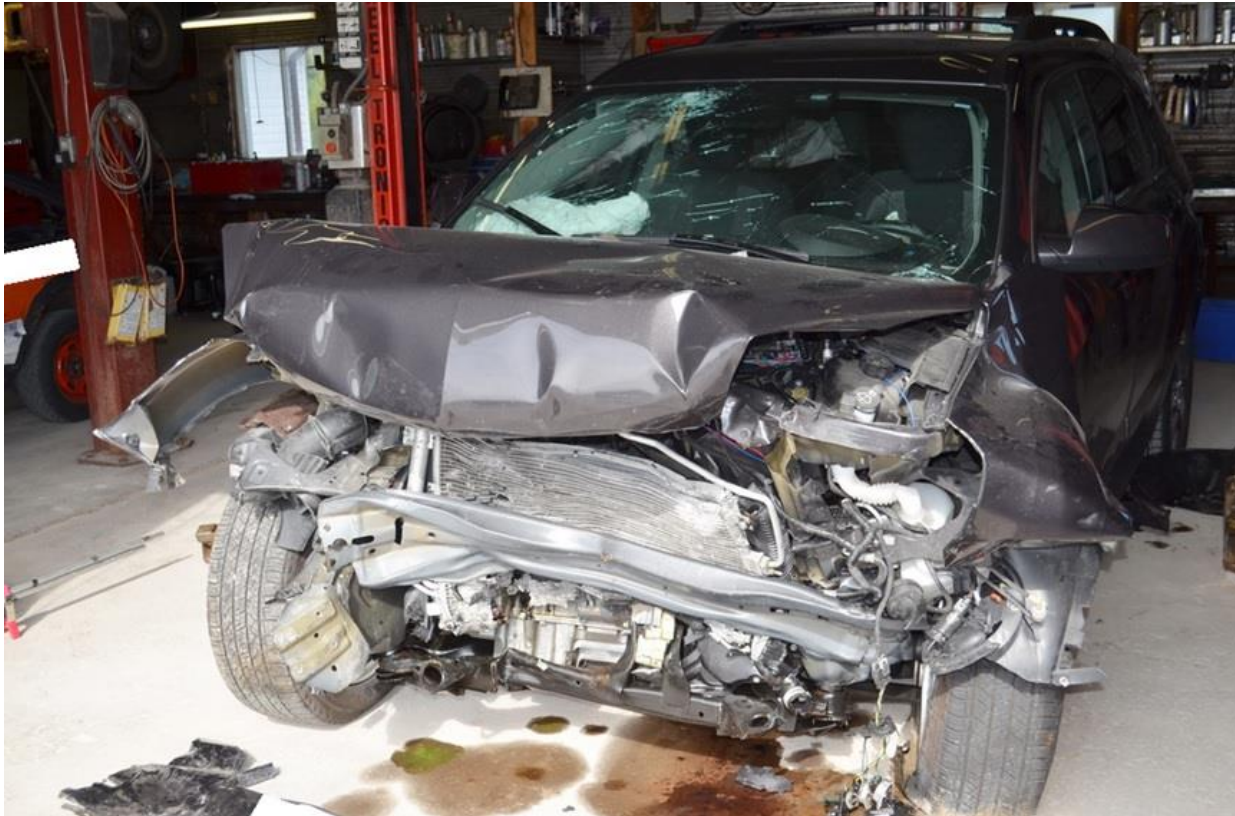
Exterior Vehicle Damage

→ Maximum frontal crush = 64cm (left corner of bumper) tapering to 36cm (right corner of bumper)

→ Hood buckled

→ Bumper fascia, grille, headlights separated from vehicle

→ Windshield fractured

→ Left front wheel jammed into wheel well

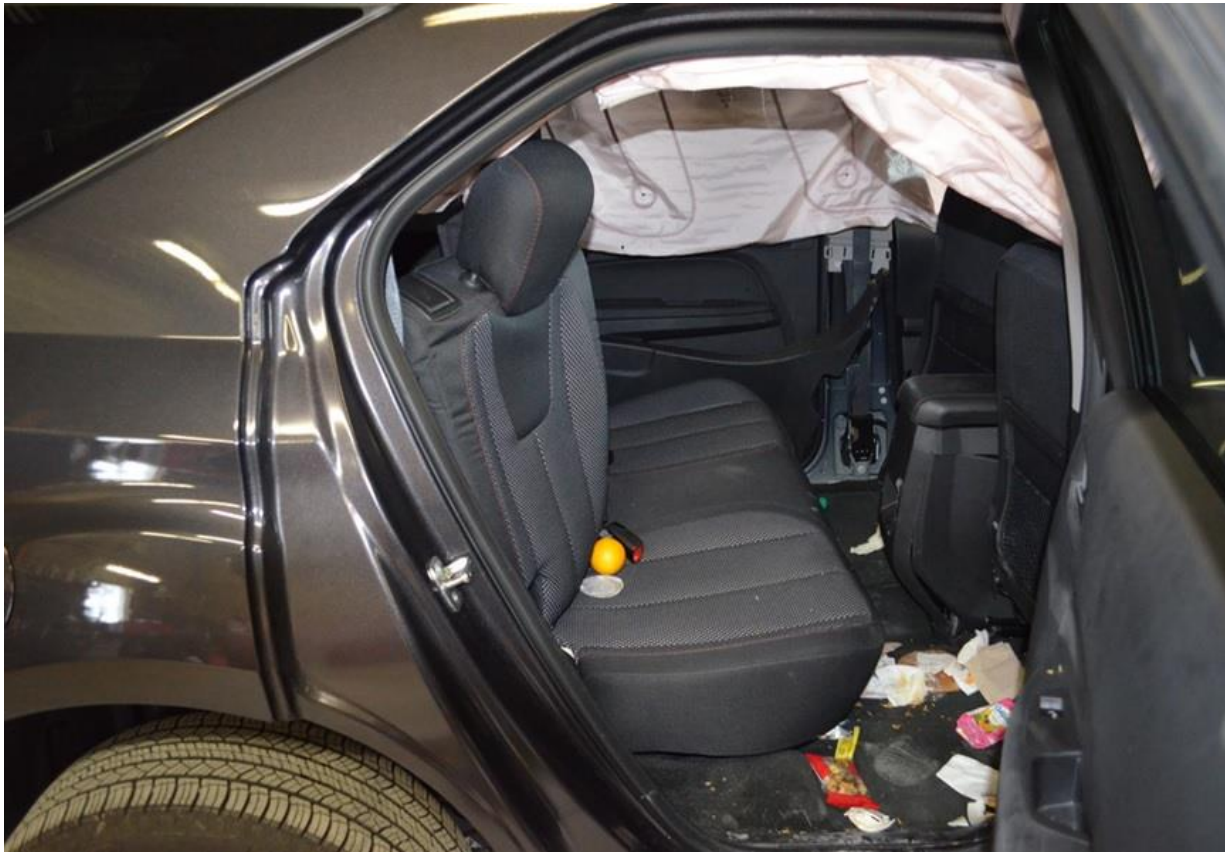
Interior Vehicle Damage

→ Intrusion at driver's floor (15 cm)

→ Front and side curtain airbags deployed

→ Deformation of driver's seatback

→ Substantial deformation of right rear occupant's seatback

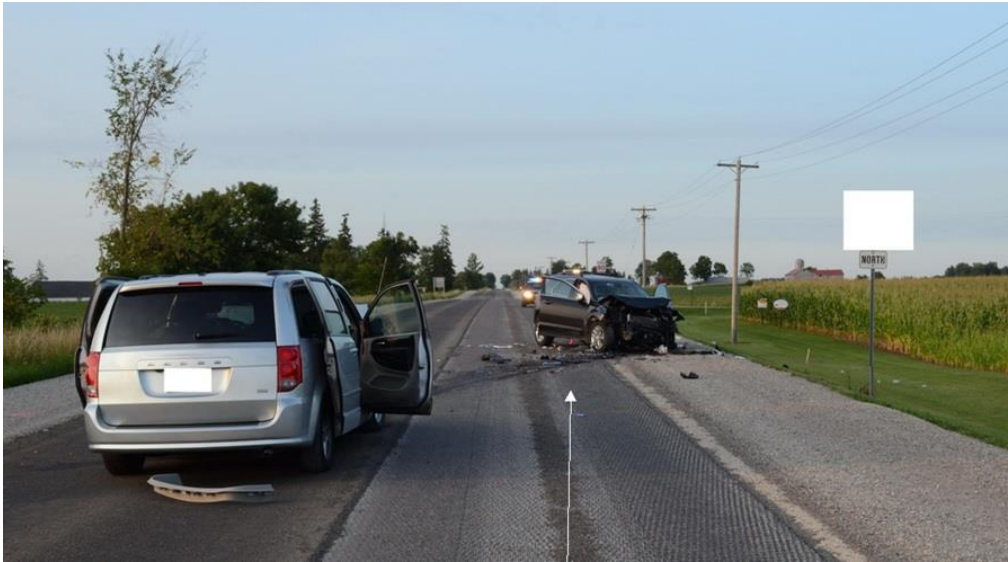
Physical Collision Analysis

→ Vehicles closing at 114 km/h at collision
(delta-V at maximum engagement = 57 km/h for both vehicles)

→ Overall delta-V = 63 km/h
(assuming 10% rebound)

→ Damage analysis (using front stiffness values) confirms EDR delta-V (57 km/h prior to rebound)

→ Severity of impact similar to frontal barrier crash test @ 55 km/h

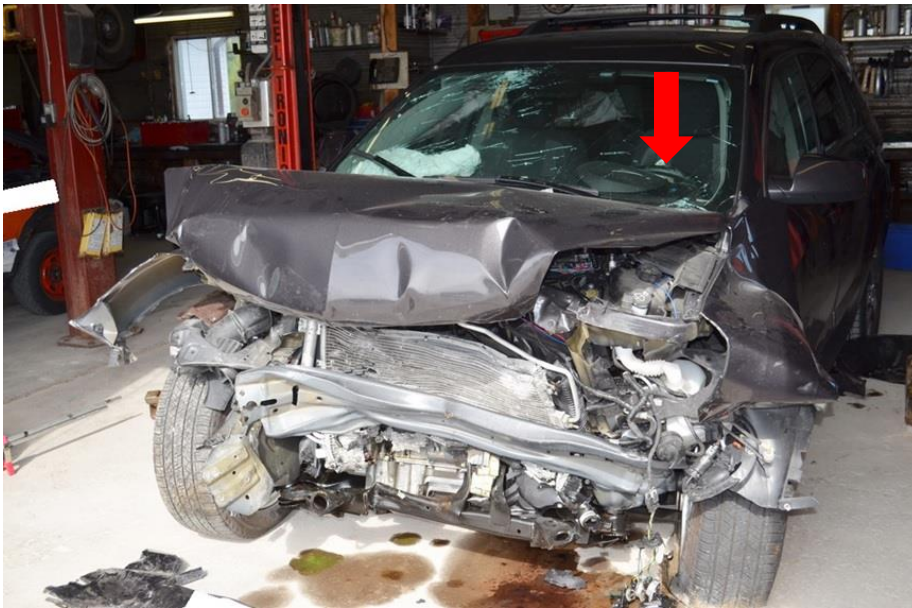
Injury Analysis - Driver

→TORSO BELT

- Displaced fracture mid-shaft left clavicle (**AIS-2**)
- Abrasions and contusions on left shoulder (**AIS-1**)

→LAP BELT

- Abrasions and contusions on the left iliac crest (**AIS-1**)

→AIRBAG

- Abrasions and contusions on left elbow (**AIS-1**)

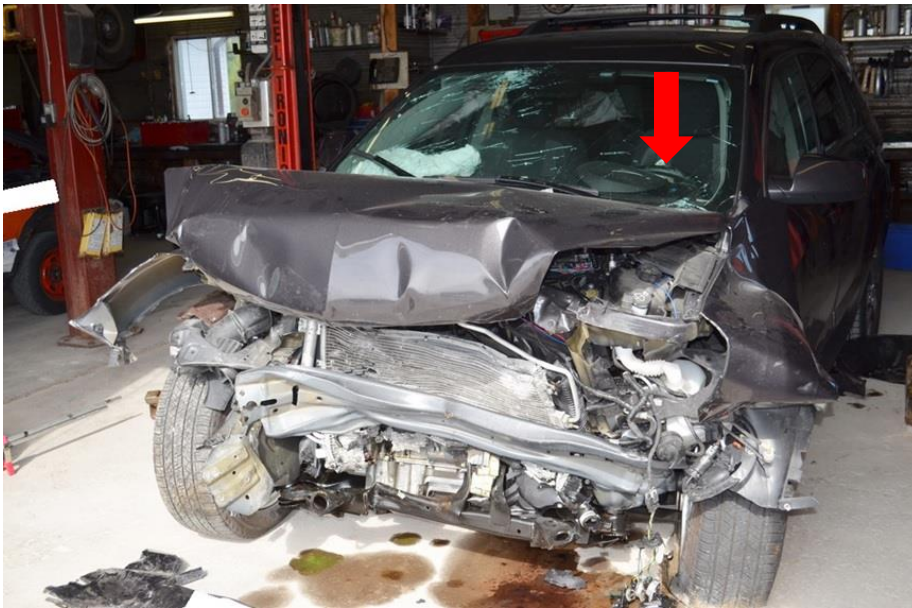
Injury Analysis - Driver

→ SEATBACK

- Abrasions and contusions on lower spine (**AIS-1**)

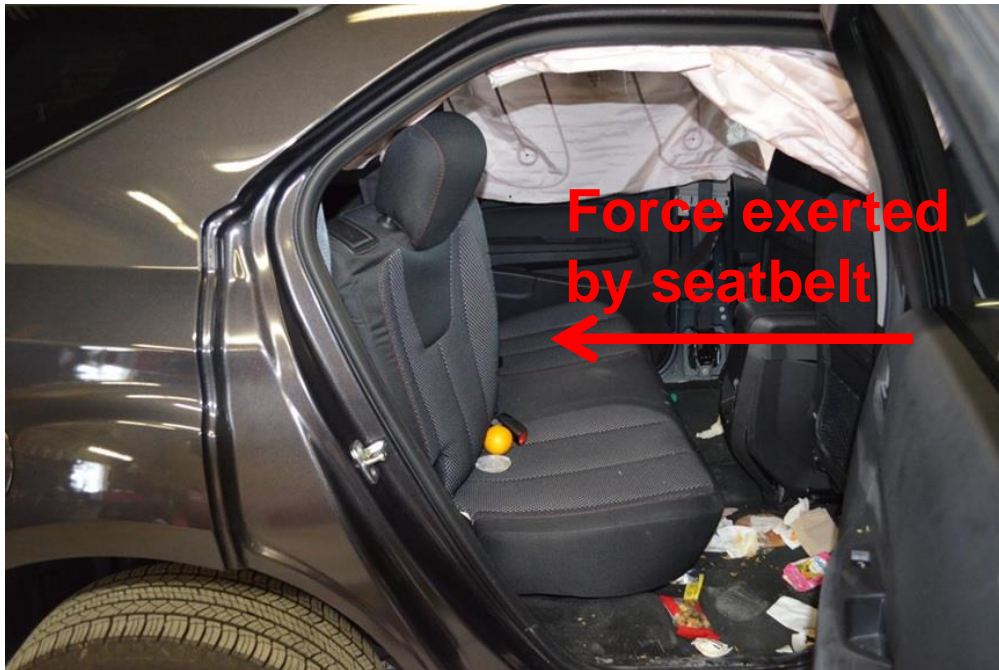
Injury Analysis - Rear Occupant

→TORSO BELT

- Right pulmonary contusions
(AIS-3)

→LAP BELT

- 3x small bowel perforations
(AIS-2)
- 3x colonic serosal tears
(AIS-2)
- Colonic full thickness perforation
(AIS-2)
- Right rectus hematoma
(AIS-2)

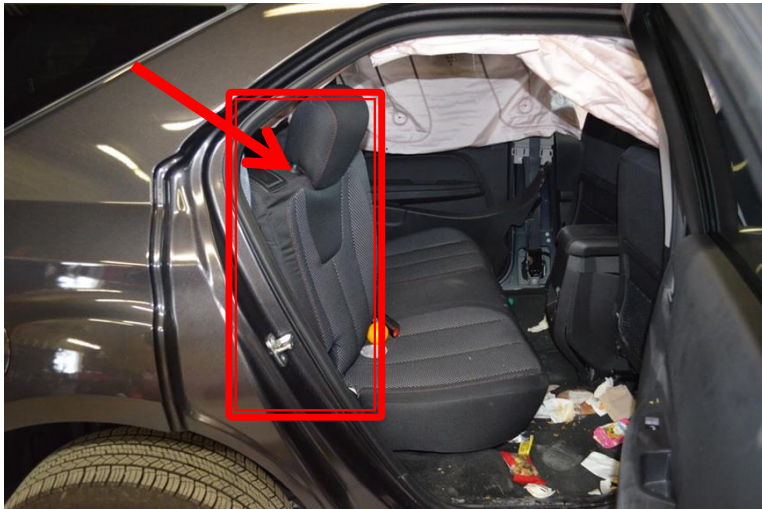
A closer look at the rear compartment...

From Case Narrative:

“Police indicated that there were a large number of heavy duffle bags in the vehicle at the time of the collision. These bags were removed prior to inspection. It is believed that they were originally situated in the rear cargo area and behind the driver on the left rear seatback which was folded down.”

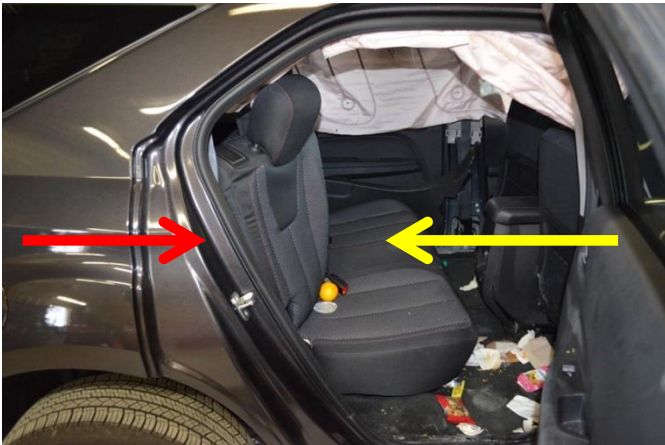
Cargo loading – a contributor to occupant injuries

Seatbelt loading / front seatback contact

+

Cargo loading (rear seatback)

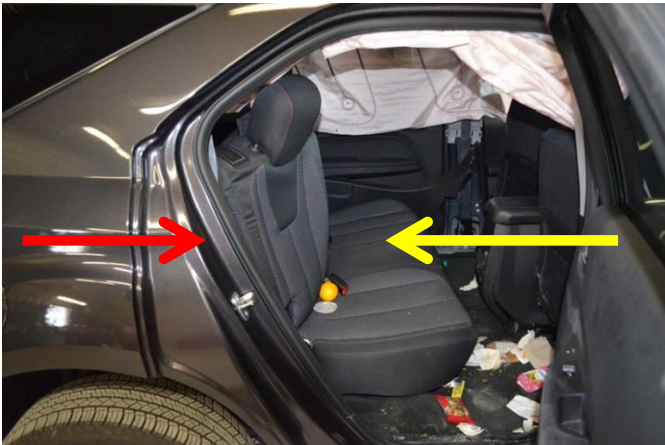
Cargo loading – a contributor to occupant injuries

Seatbelt loading

+

Cargo loading (rear seatback)

- Right rectus hematoma
(AIS-2)
- 3x small bowel perforations
(AIS-2)
- 3x colonic serosal tears
(AIS-2)
- Colonic full thickness perforation
(AIS-2)

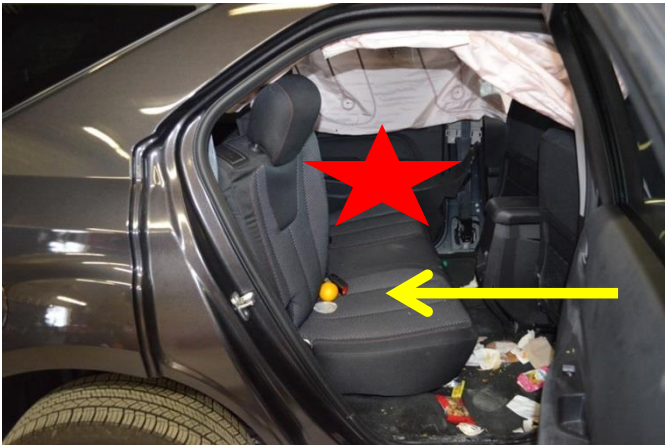
Cargo loading – a contributor to occupant injuries

Front seatback contact

+

Cargo shifting (rear compartment)

- Concussion
(AIS-2)
- Nose bridge laceration
(AIS-1)
- Right nose laceration
(AIS-1)
