Assessment of Wheel Separations from Light-Duty Vehicles

CARSP Conference
June 20, 2017

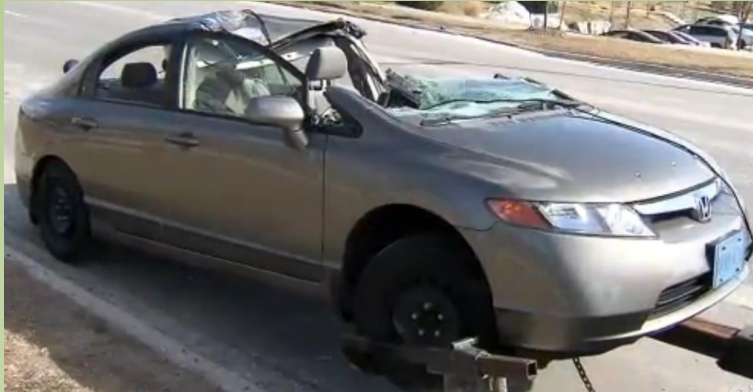
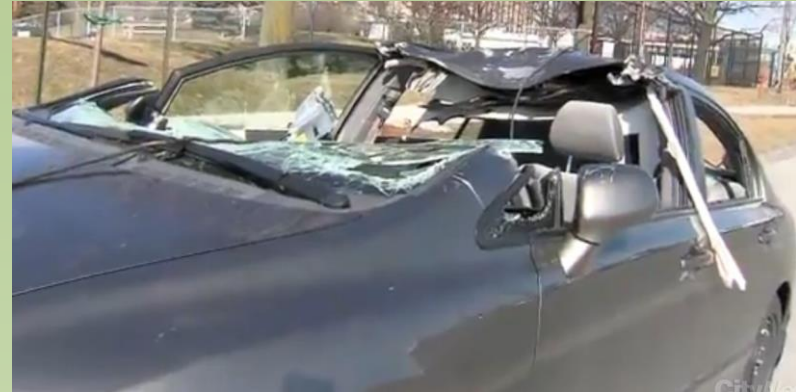
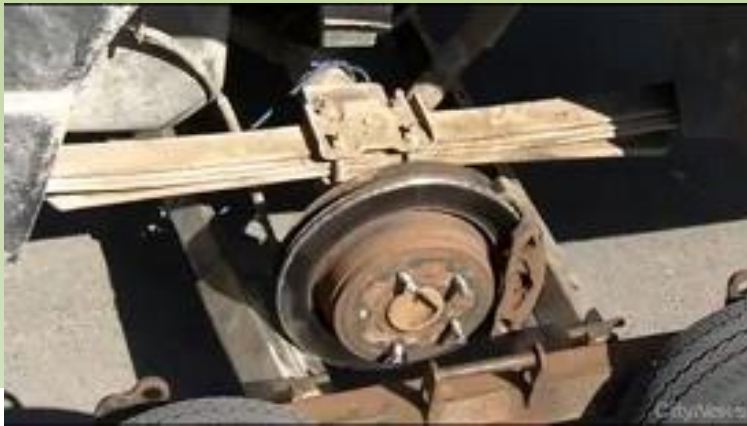
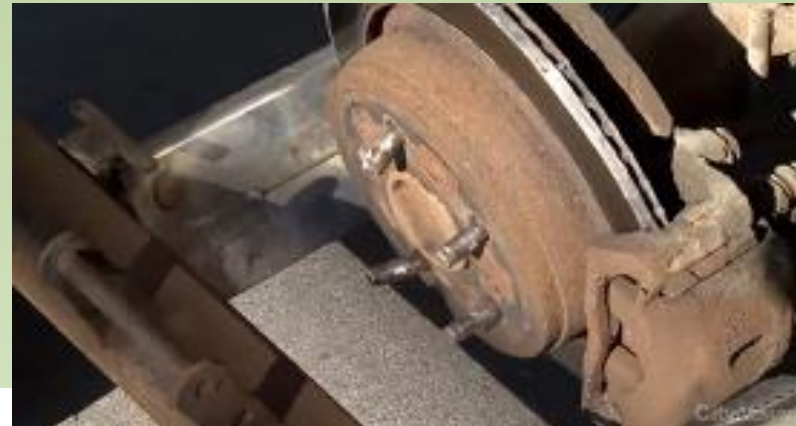
March 15, 2013 – Pick-up truck tire impacted Honda Civic roof

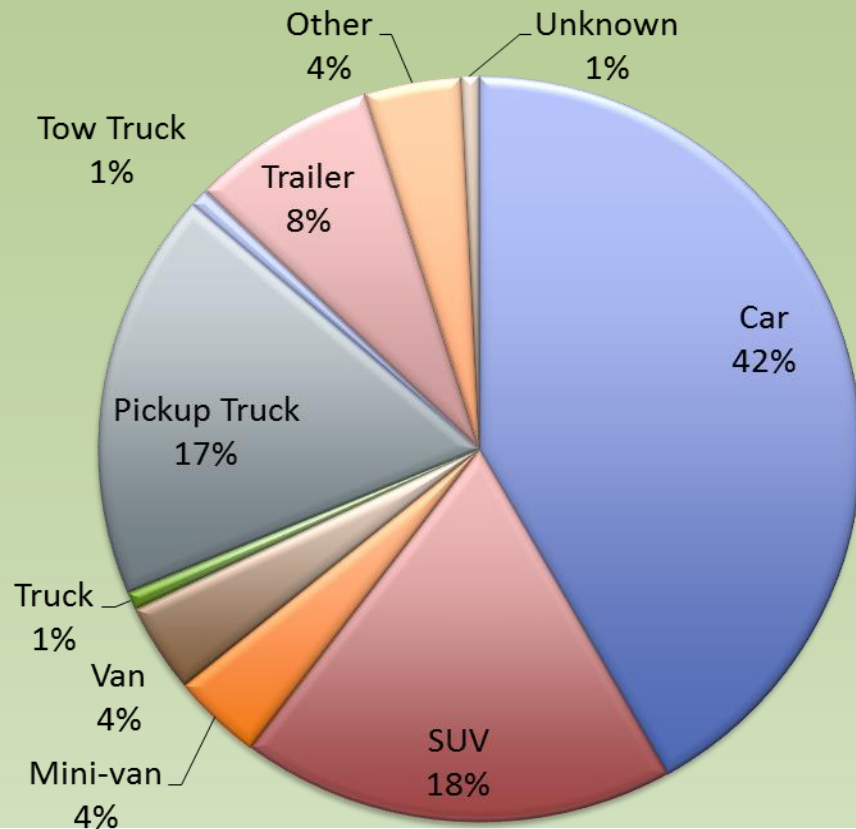
Composition of LDVs in Data

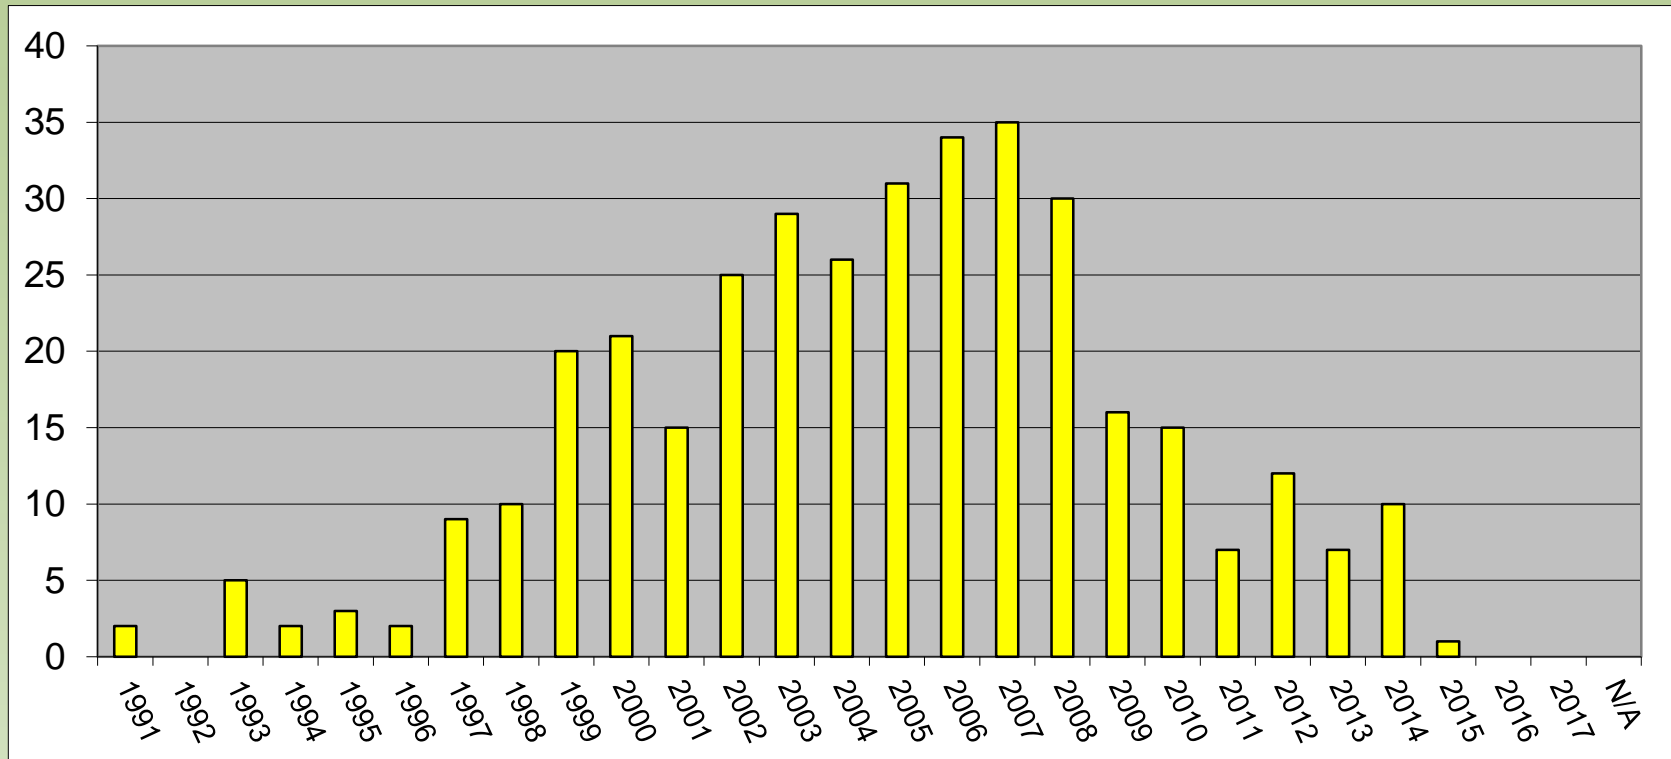
LDV model year distribution

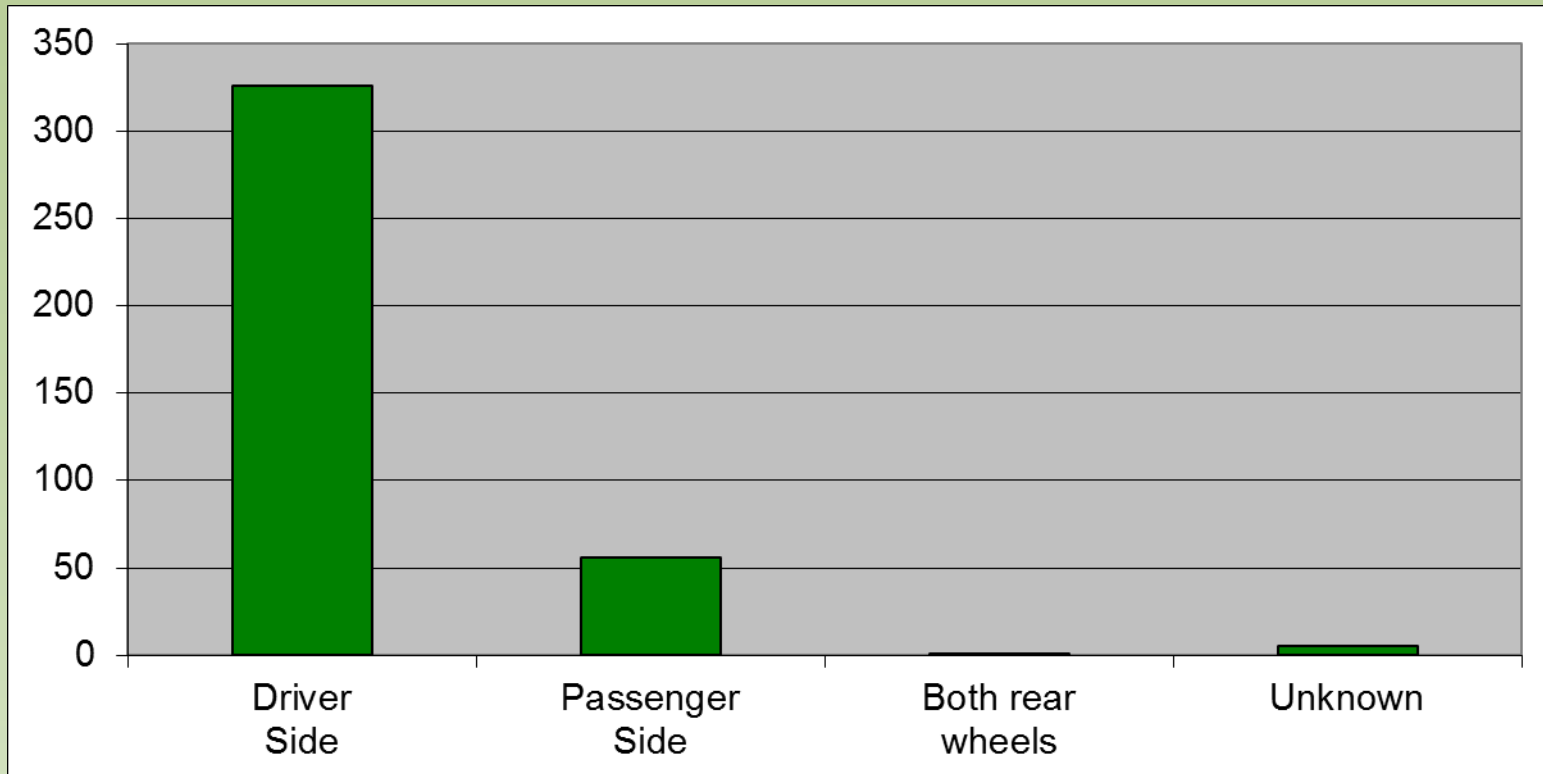
Side from which wheel was released

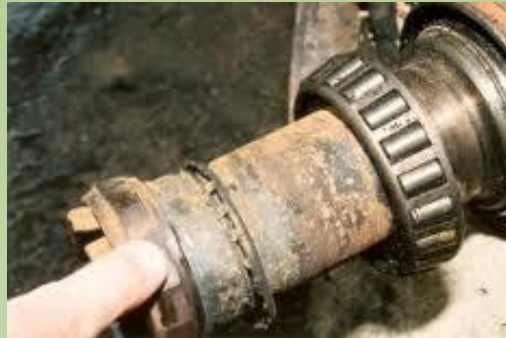
fasteners

- ❖ Ensure mating surfaces are clean & corrosion free
- ❖ Centre hub & hub-mating surface – motor oil lightly
- ❖ Ensure that fastener threads are clean
- ❖ Do not lubricate fastener or mating threads
- ❖ Install all rim-to-hub fasteners finger-tight
- ❖ Progressively tighten fasteners in “star” pattern
- ❖ Tighten to vehicle manufacturer-recommended torque
- ❖ Perform torque check(s) as specified by manufacturer

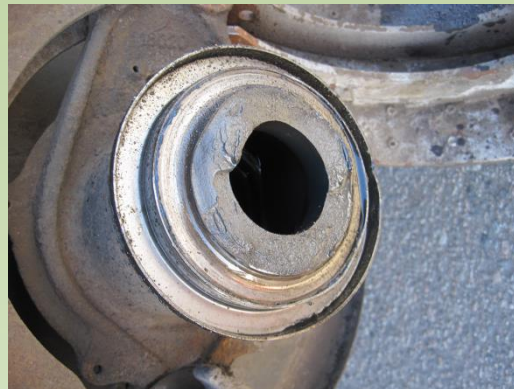
wheel bearing

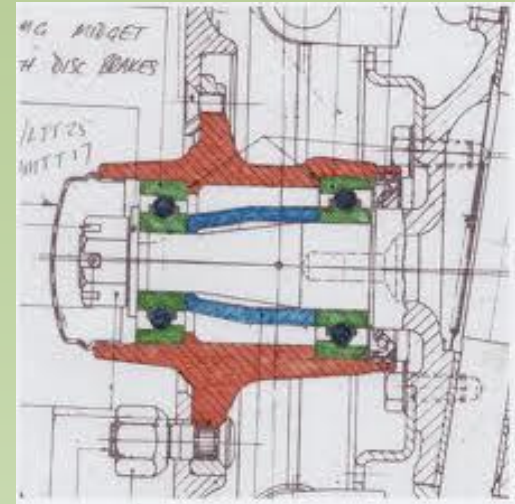
broken axle

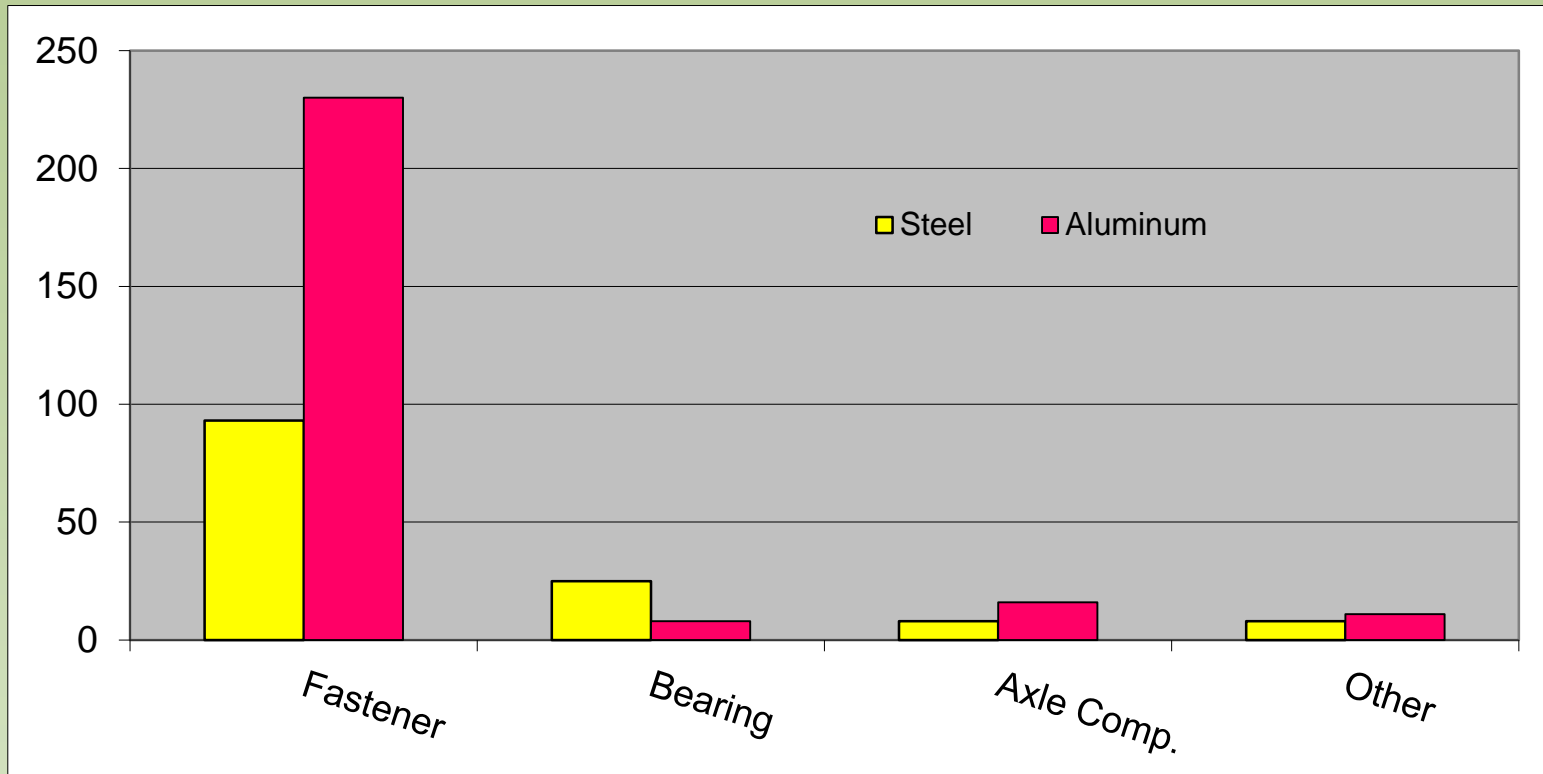
Causes of wheel separation

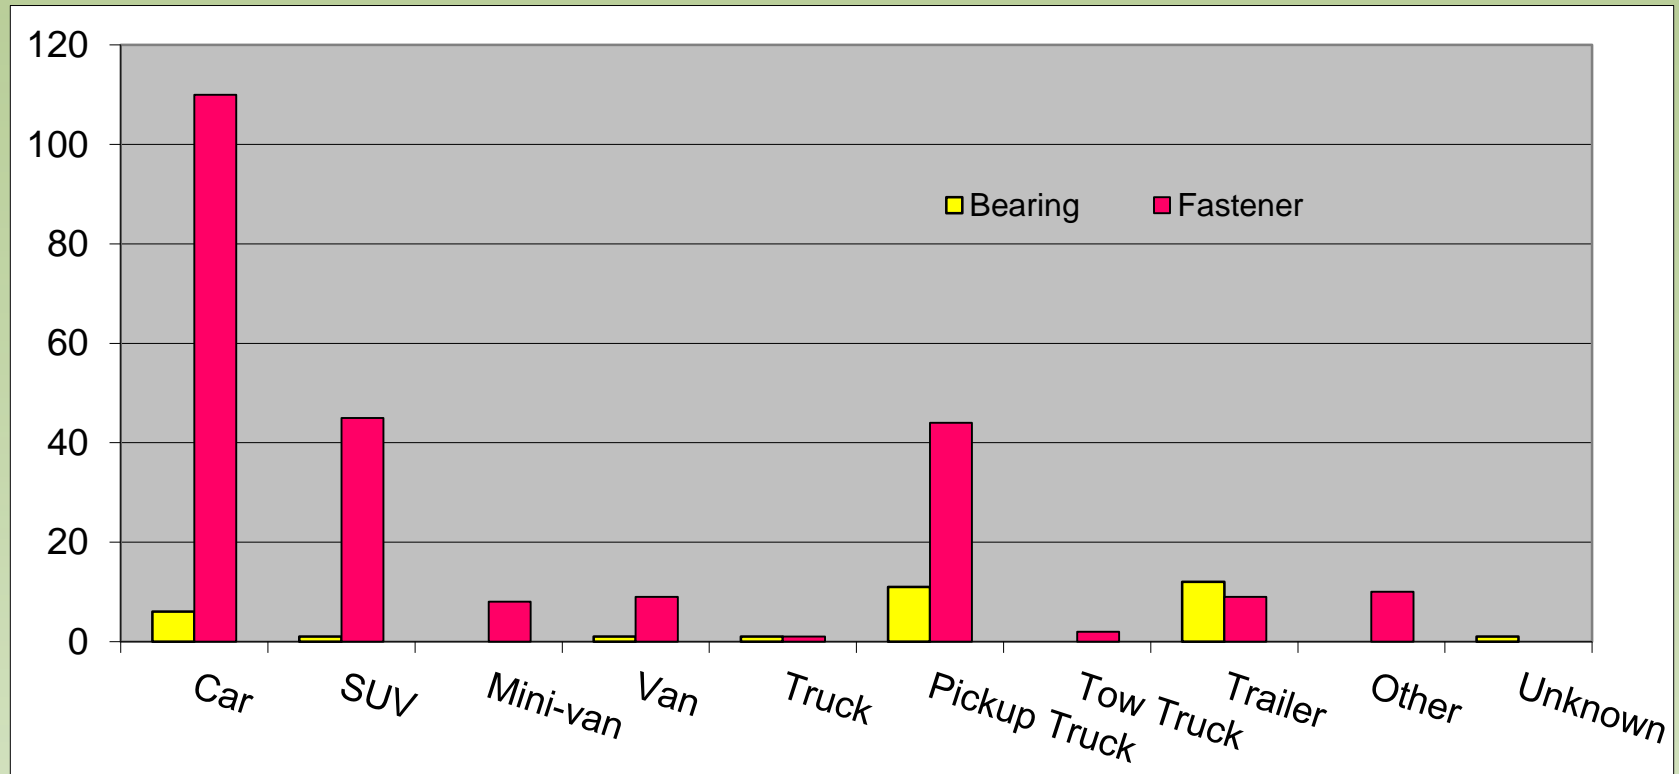
Bearing versus fastener by vehicle type

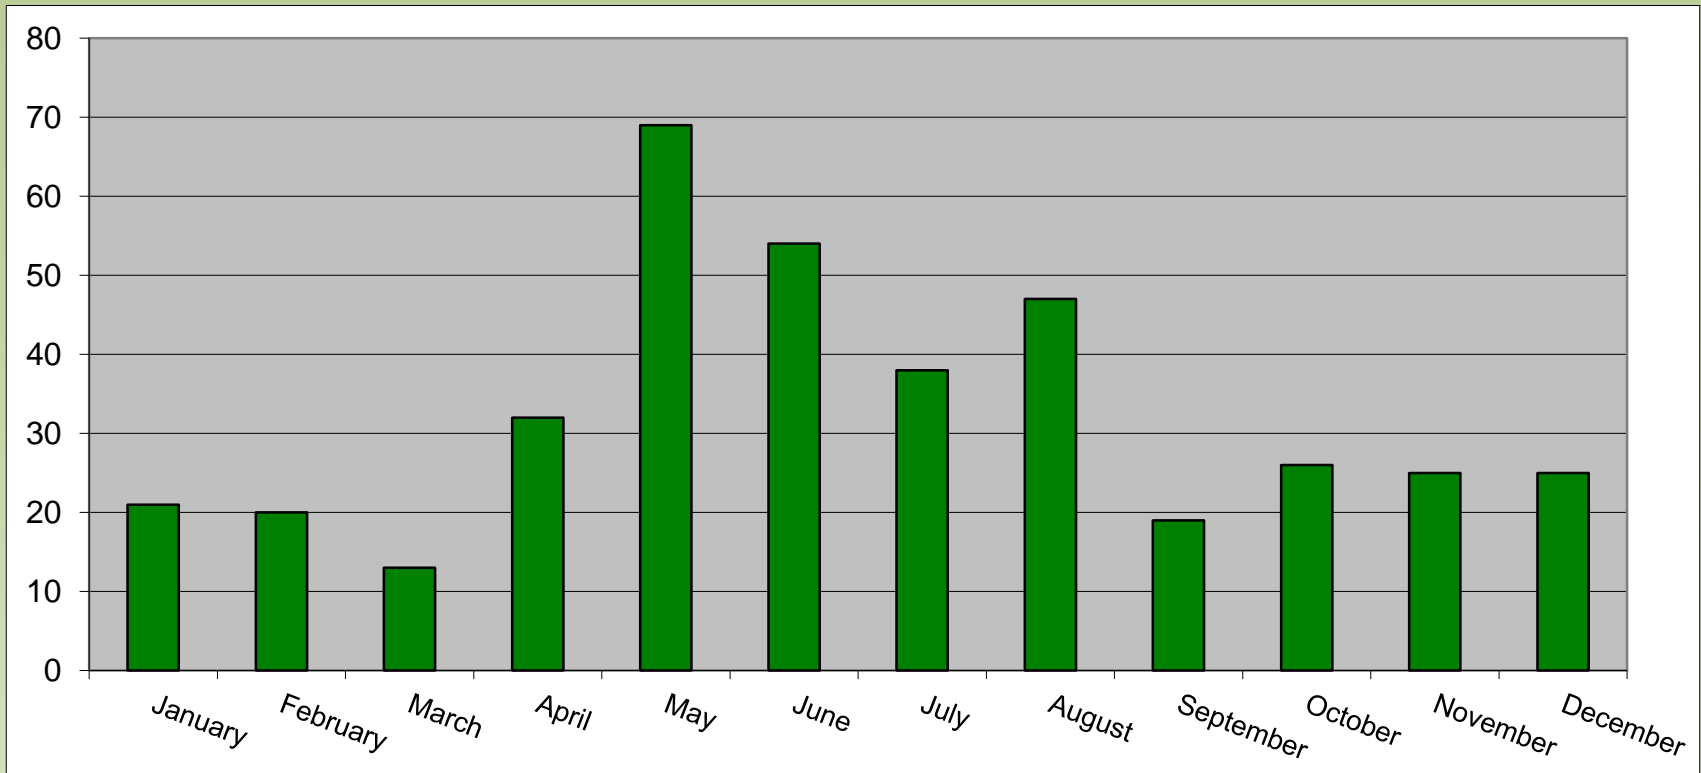
Month of wheel separation occurrence

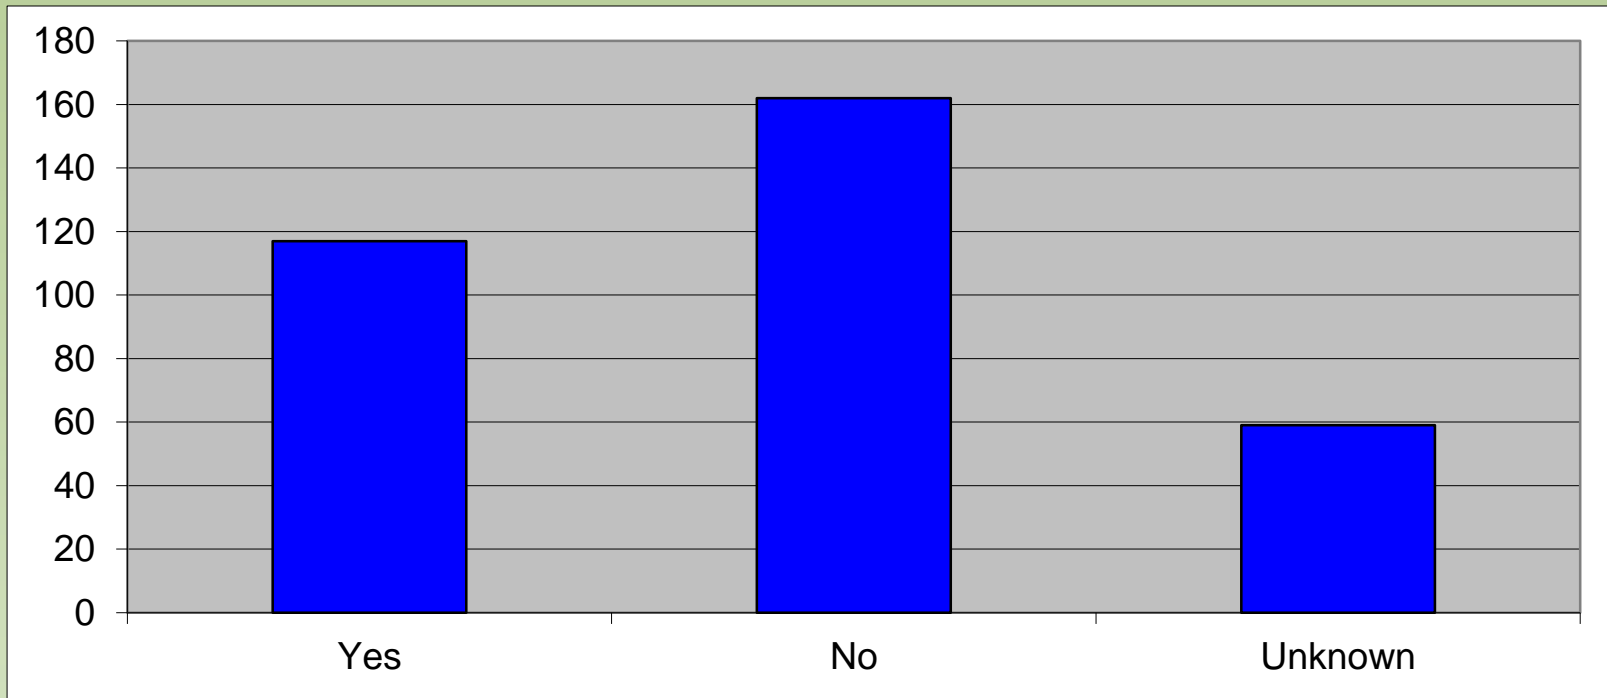
Did wheel separation follow a seasonal tire change?

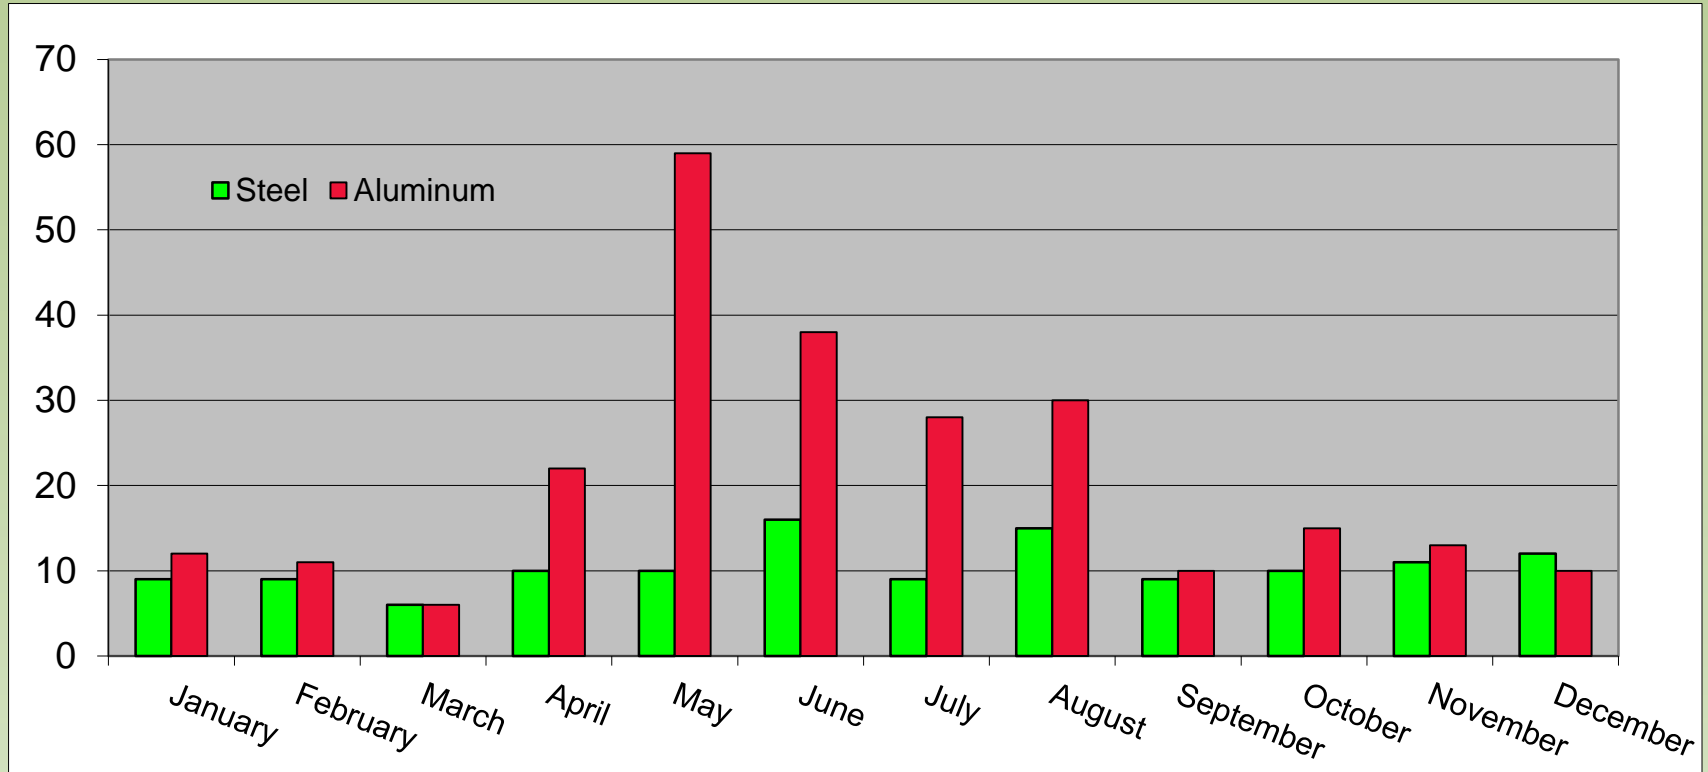
Wheel Composition by Month of Separation

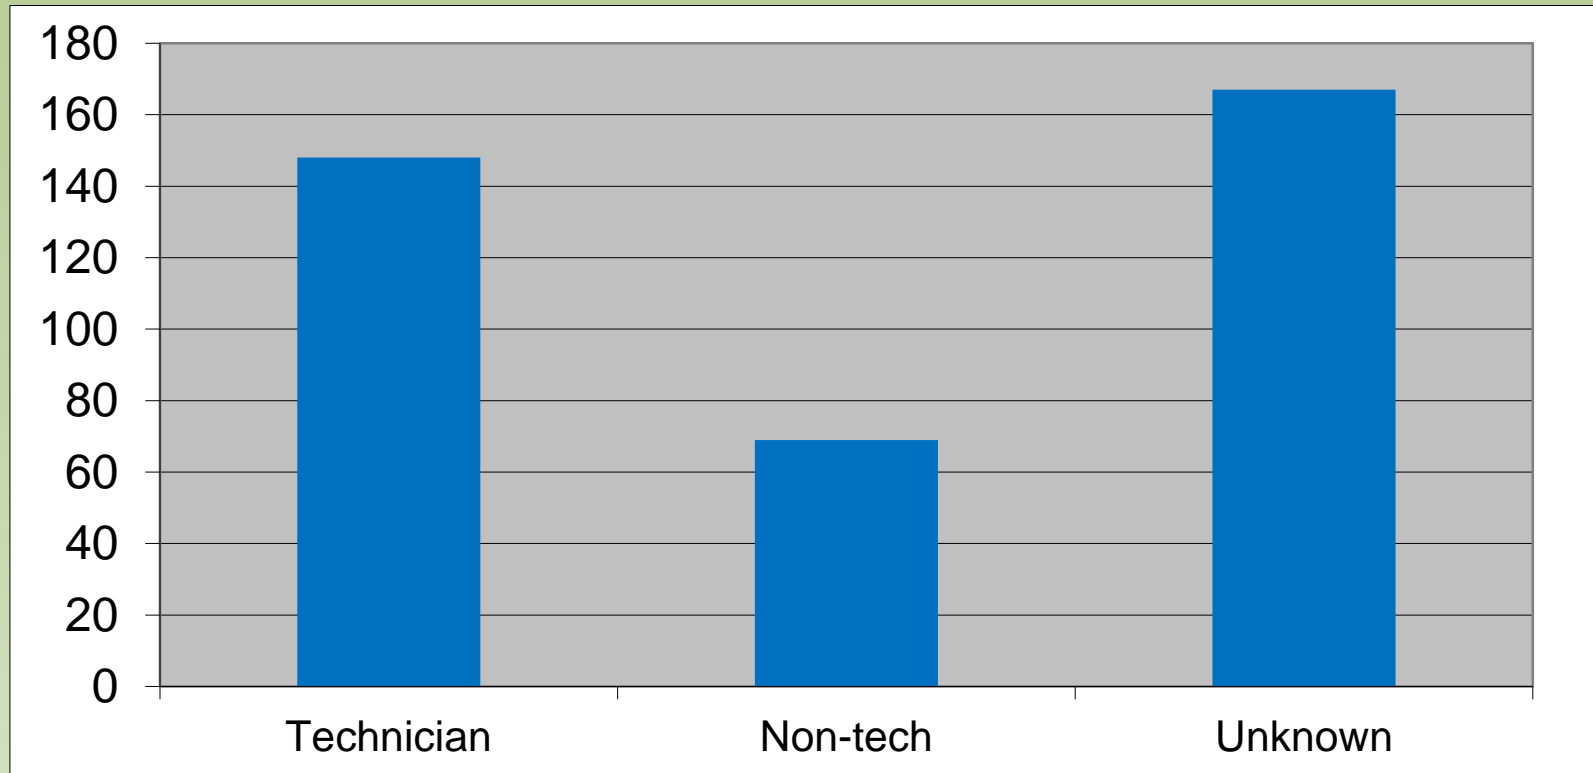
Qualification of wheel installer prior to separation

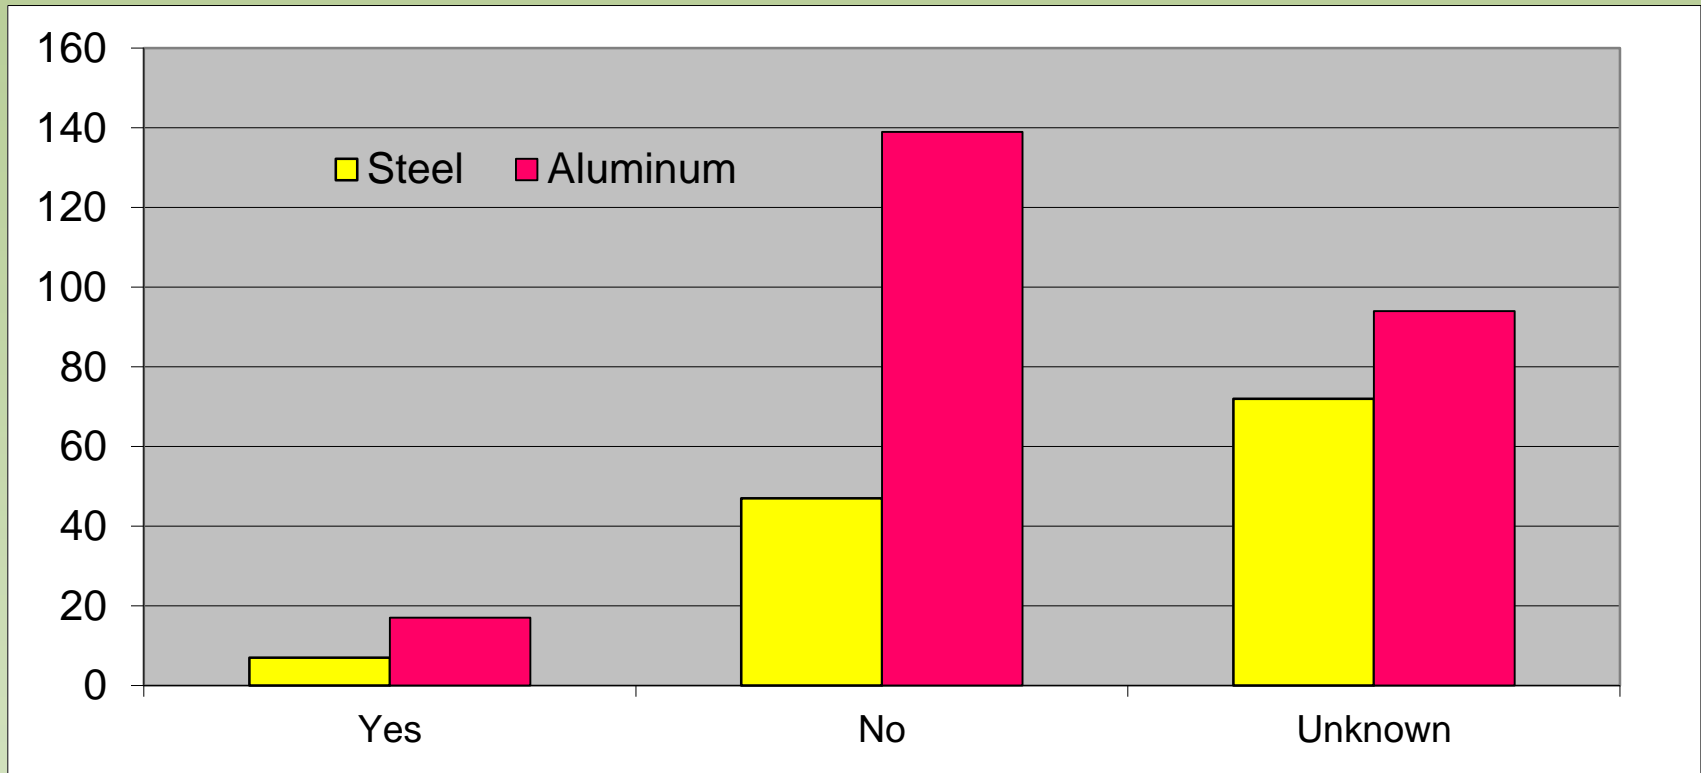
Torque check performed prior to wheel separation?

Industry standard practices
follow-up with torque checks

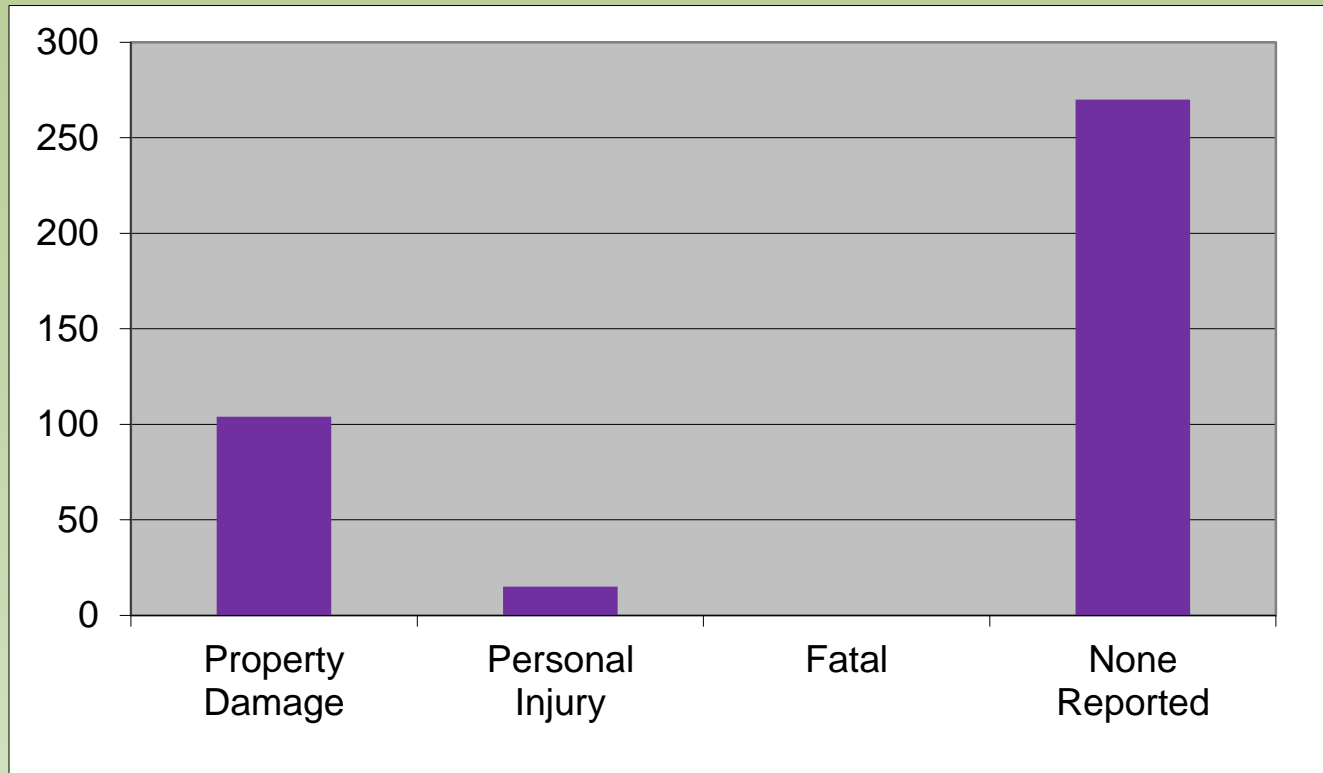
Damage caused by wheel separation

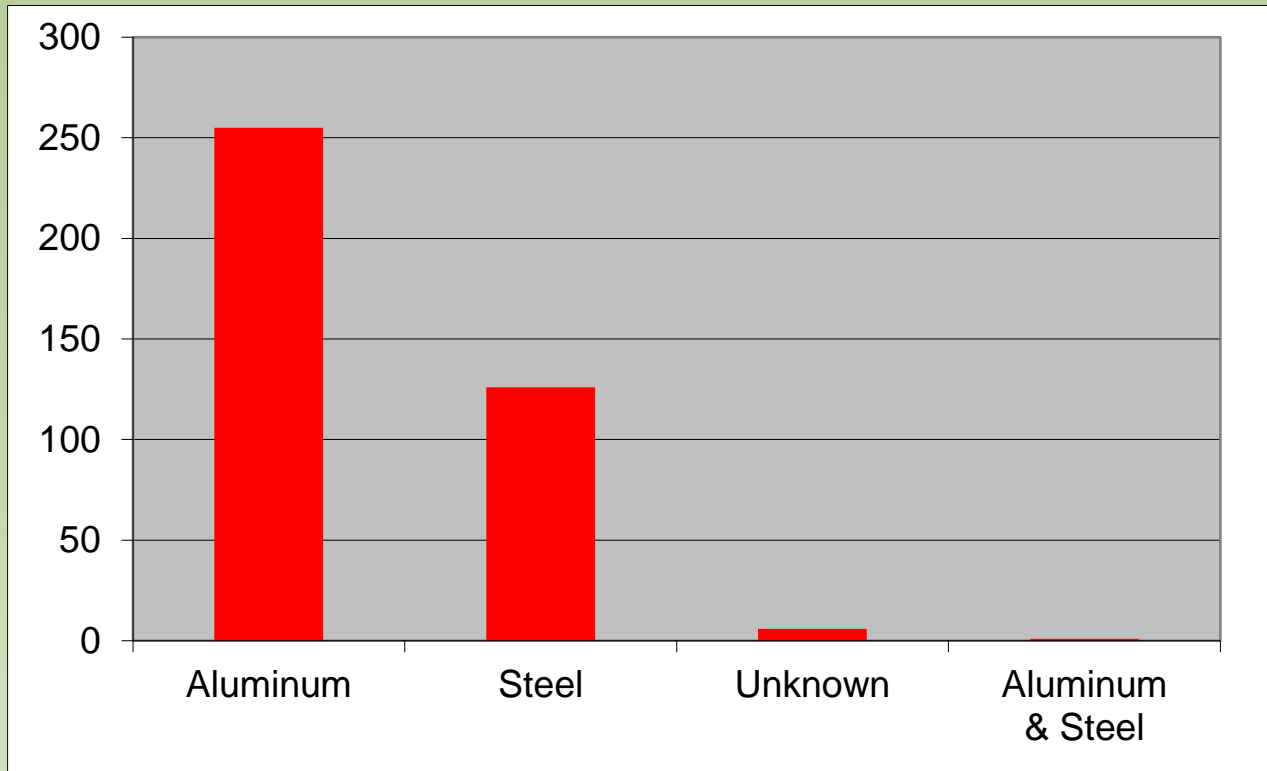
Rim Composition
