Road Safety Investigation at Roundabouts in Toowoomba

Somasundaraswaran, K & Richardson, M

School of Civil Engineering and Surveying

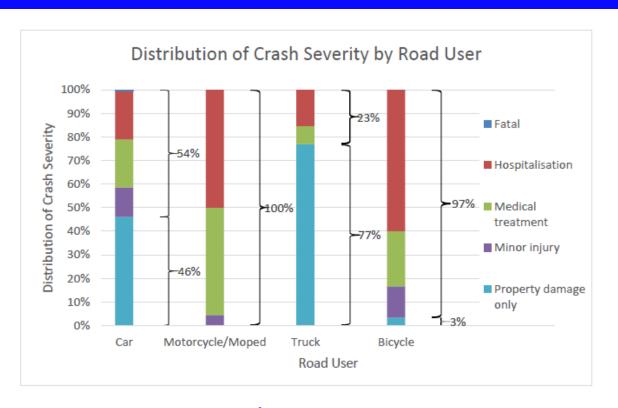
Weighting factors based on users

Non-PD type: Motorcycle – Car = 100-54 = 46%

Weighting factor for motorcycle road users = 1.46

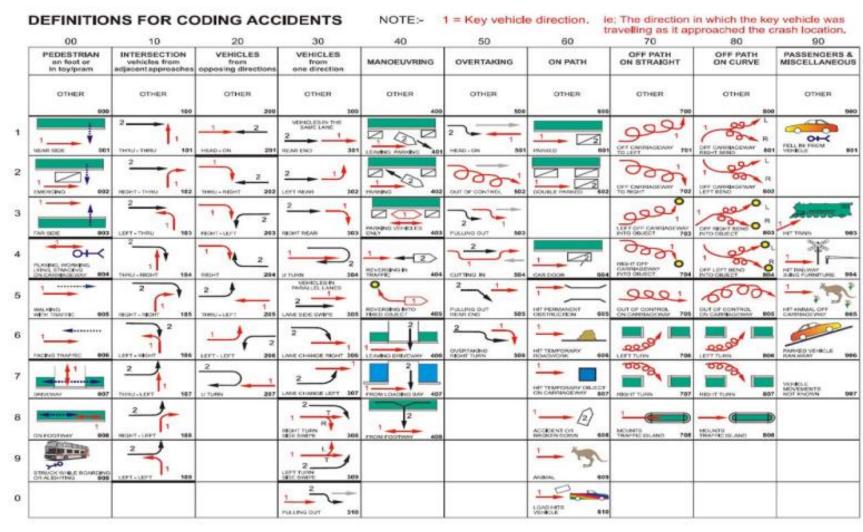
Definitions for coding crashes-QLD

(Source: Austroads 2009)

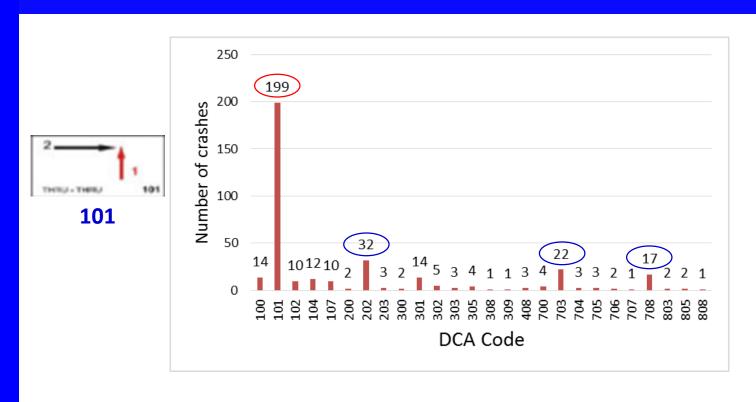
Types of crashes at roundabouts

- **101** Vehicles from adjacent approaches collide
- **202** Vehicles from opposing directions with one turning right
- **703** Vehicle heading left of carriageway into an object
- 708 Non-collision on straight right onto traffic island

- Code 101 Accounted over half of all crashes.
- Collisions occurred more frequently at entrances to roundabouts.
- About three-quarters of the crashes involved property damage only.
- The crashes often involved unsafe speeds.

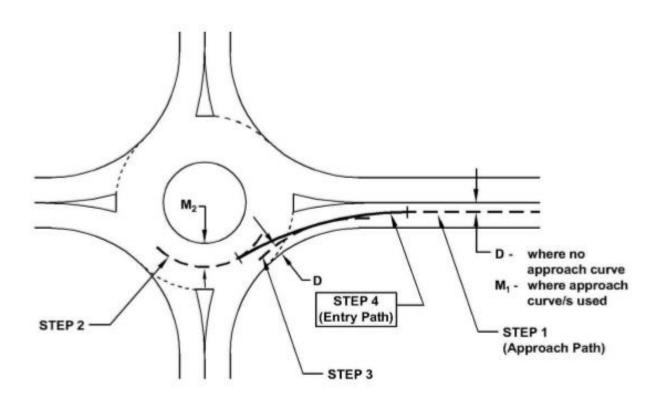
Entry path for a single-lane entry

D = 1.5 m when measuring from a road centreline or kerb face, 1.0 m when measuring from an edge line.

M, = Half the width of the approach lane.

M₂ = Half of the width of the circulating carriageway.

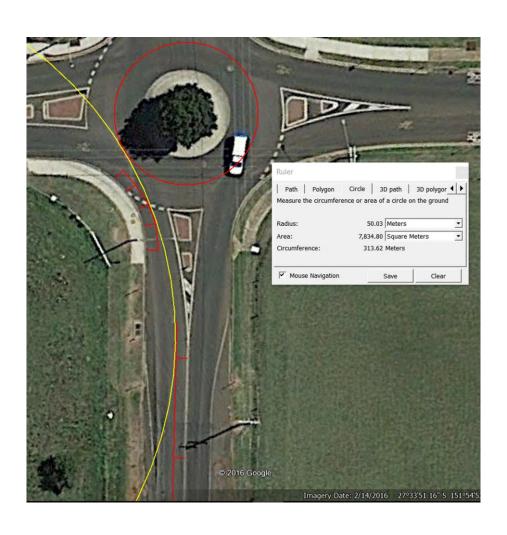
Measuring Radii- Google Earth Property

SW7 - Glenvale Rd and McDougall St

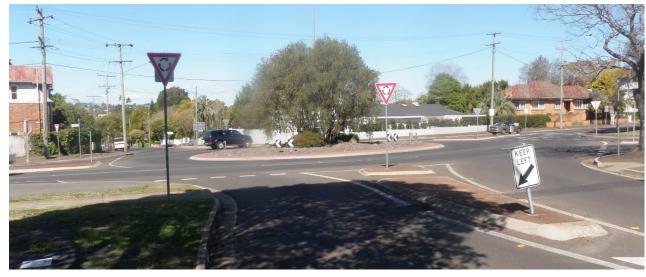
Rank 2 – NW6 (Anzac/West/Russell)

- 36 Road Crashes
- OF, 5H, 7MT, 6MI &18PDO
- Traffic Volume = 23,387 vph

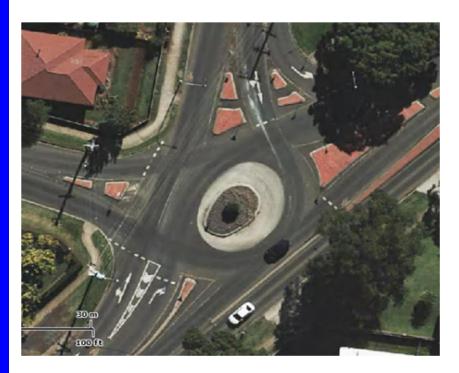
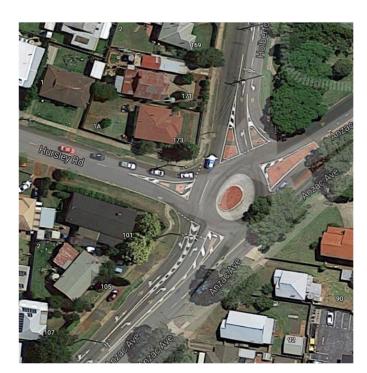
Before and after [Anzac-Ave, Holberton St and Hursley Rd]

Anzac-Avenue roundabout

Problem: 54 crashes (18 life-threatening Injuries)

- High approach speeds
- High traffic volumes (17K)

- Vehicle Activated Sign (VAS)
- Delineation
- Surface friction improvements

- Crash Reduction: 65%
- Benefit Cost Ratio (BCR): 14.3
- Outcome: 1 PDO crash since Sept 2015!

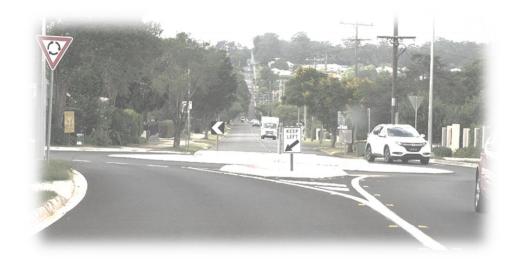
South and Rowbotham Street

Problem: 12 crashes (7 life-threatening injuries)

- Control, sight distances, vertical Curve
- High conflict volumes (2,900 and 1,900 AADT's)

Single lane Roundabout

Crash Reduction: 85%

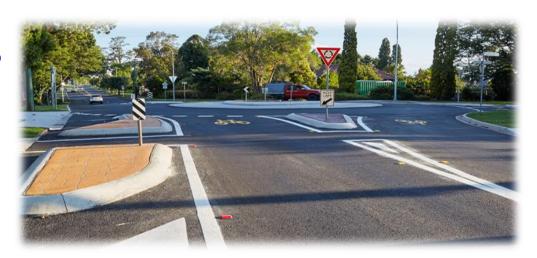
Margaret / Dawnie Street Intersection

Problem: 10 crashes (6 life-threatening injuries)

- Crest vertical intersection
- Control resembles 'T-Intersection'

Single lane roundabout

Crash Reduction: 85%
