Pedestrian Safety at At-Grade Crossings

Outline

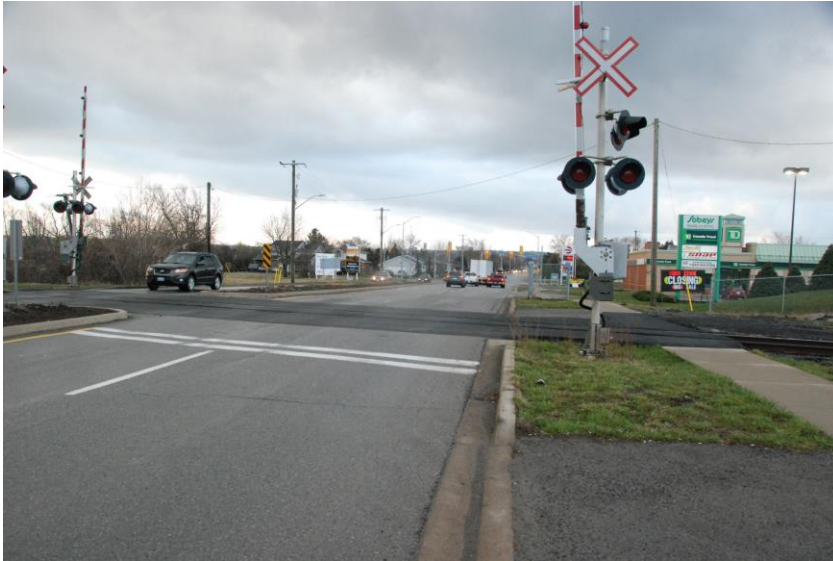
Crossing with a roadway that includes an offset sidewalk

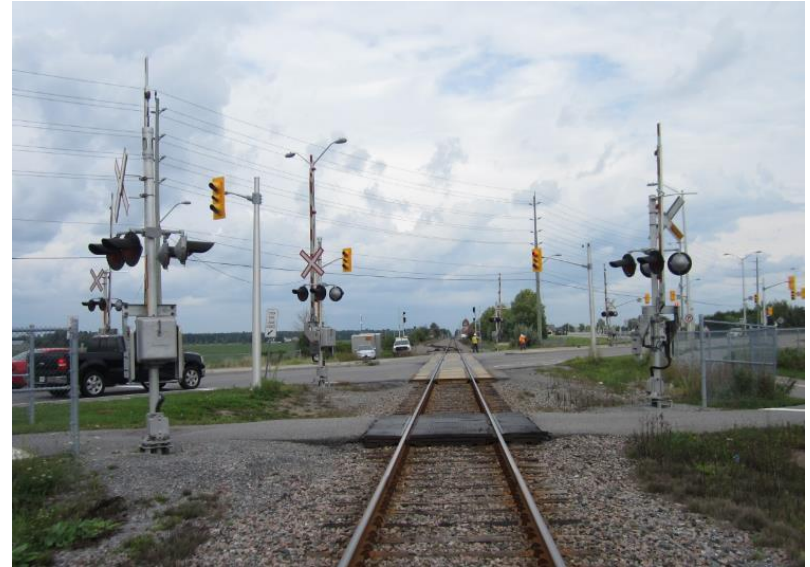
Crossing with a walkway/path/trail

Although the requirements are not as stringent for crossings with a sidewalk/path/trail, any public facility intended to be used by pedestrians/cyclists is required to comply with the new regulations.

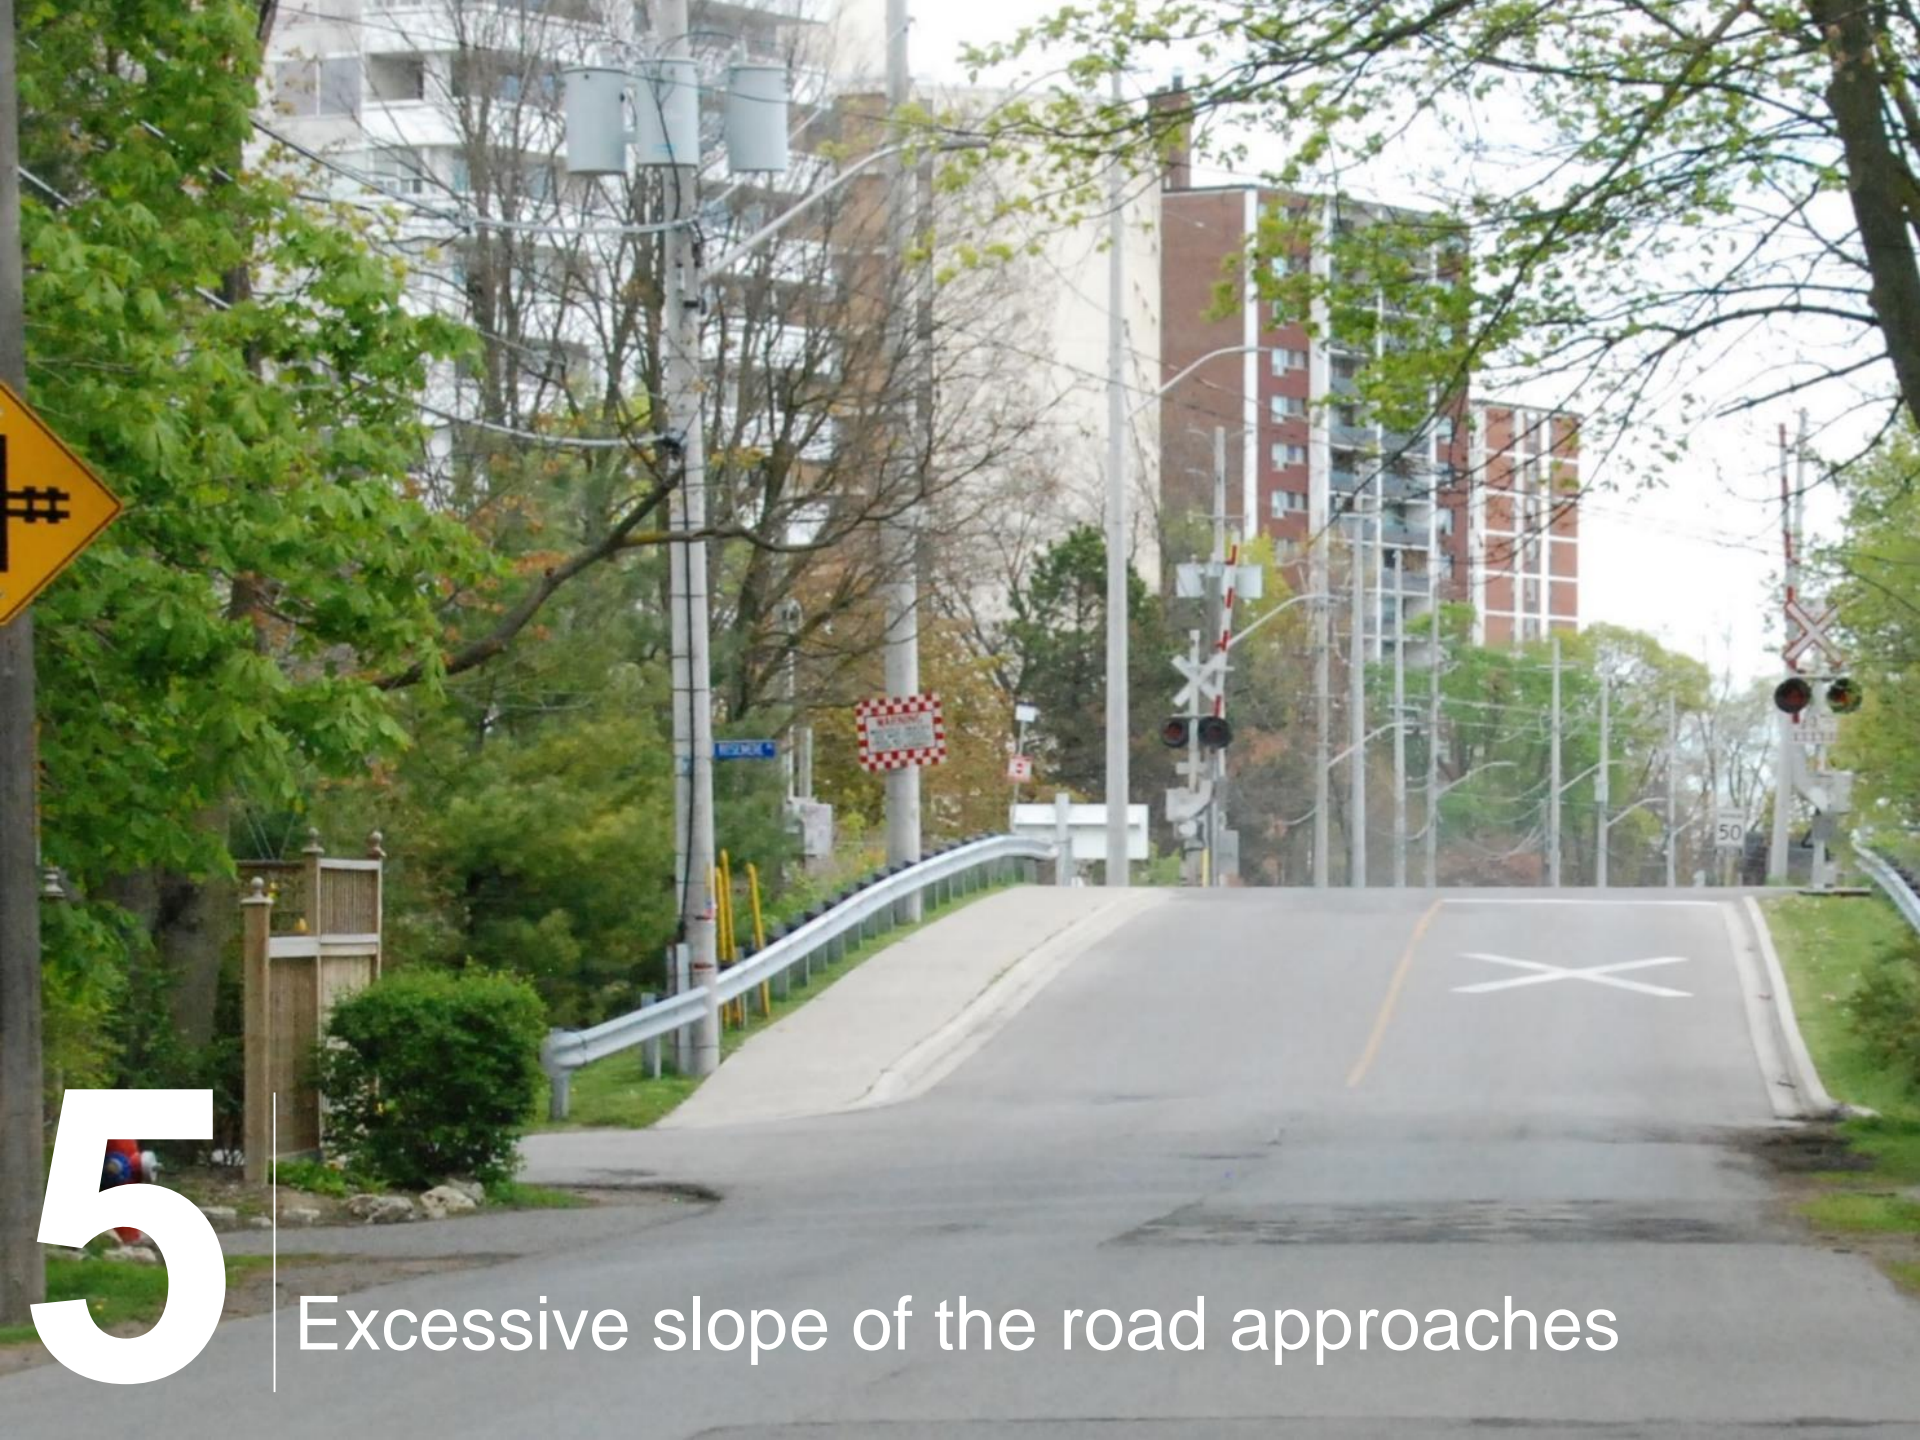
Excessive slope of the road approaches

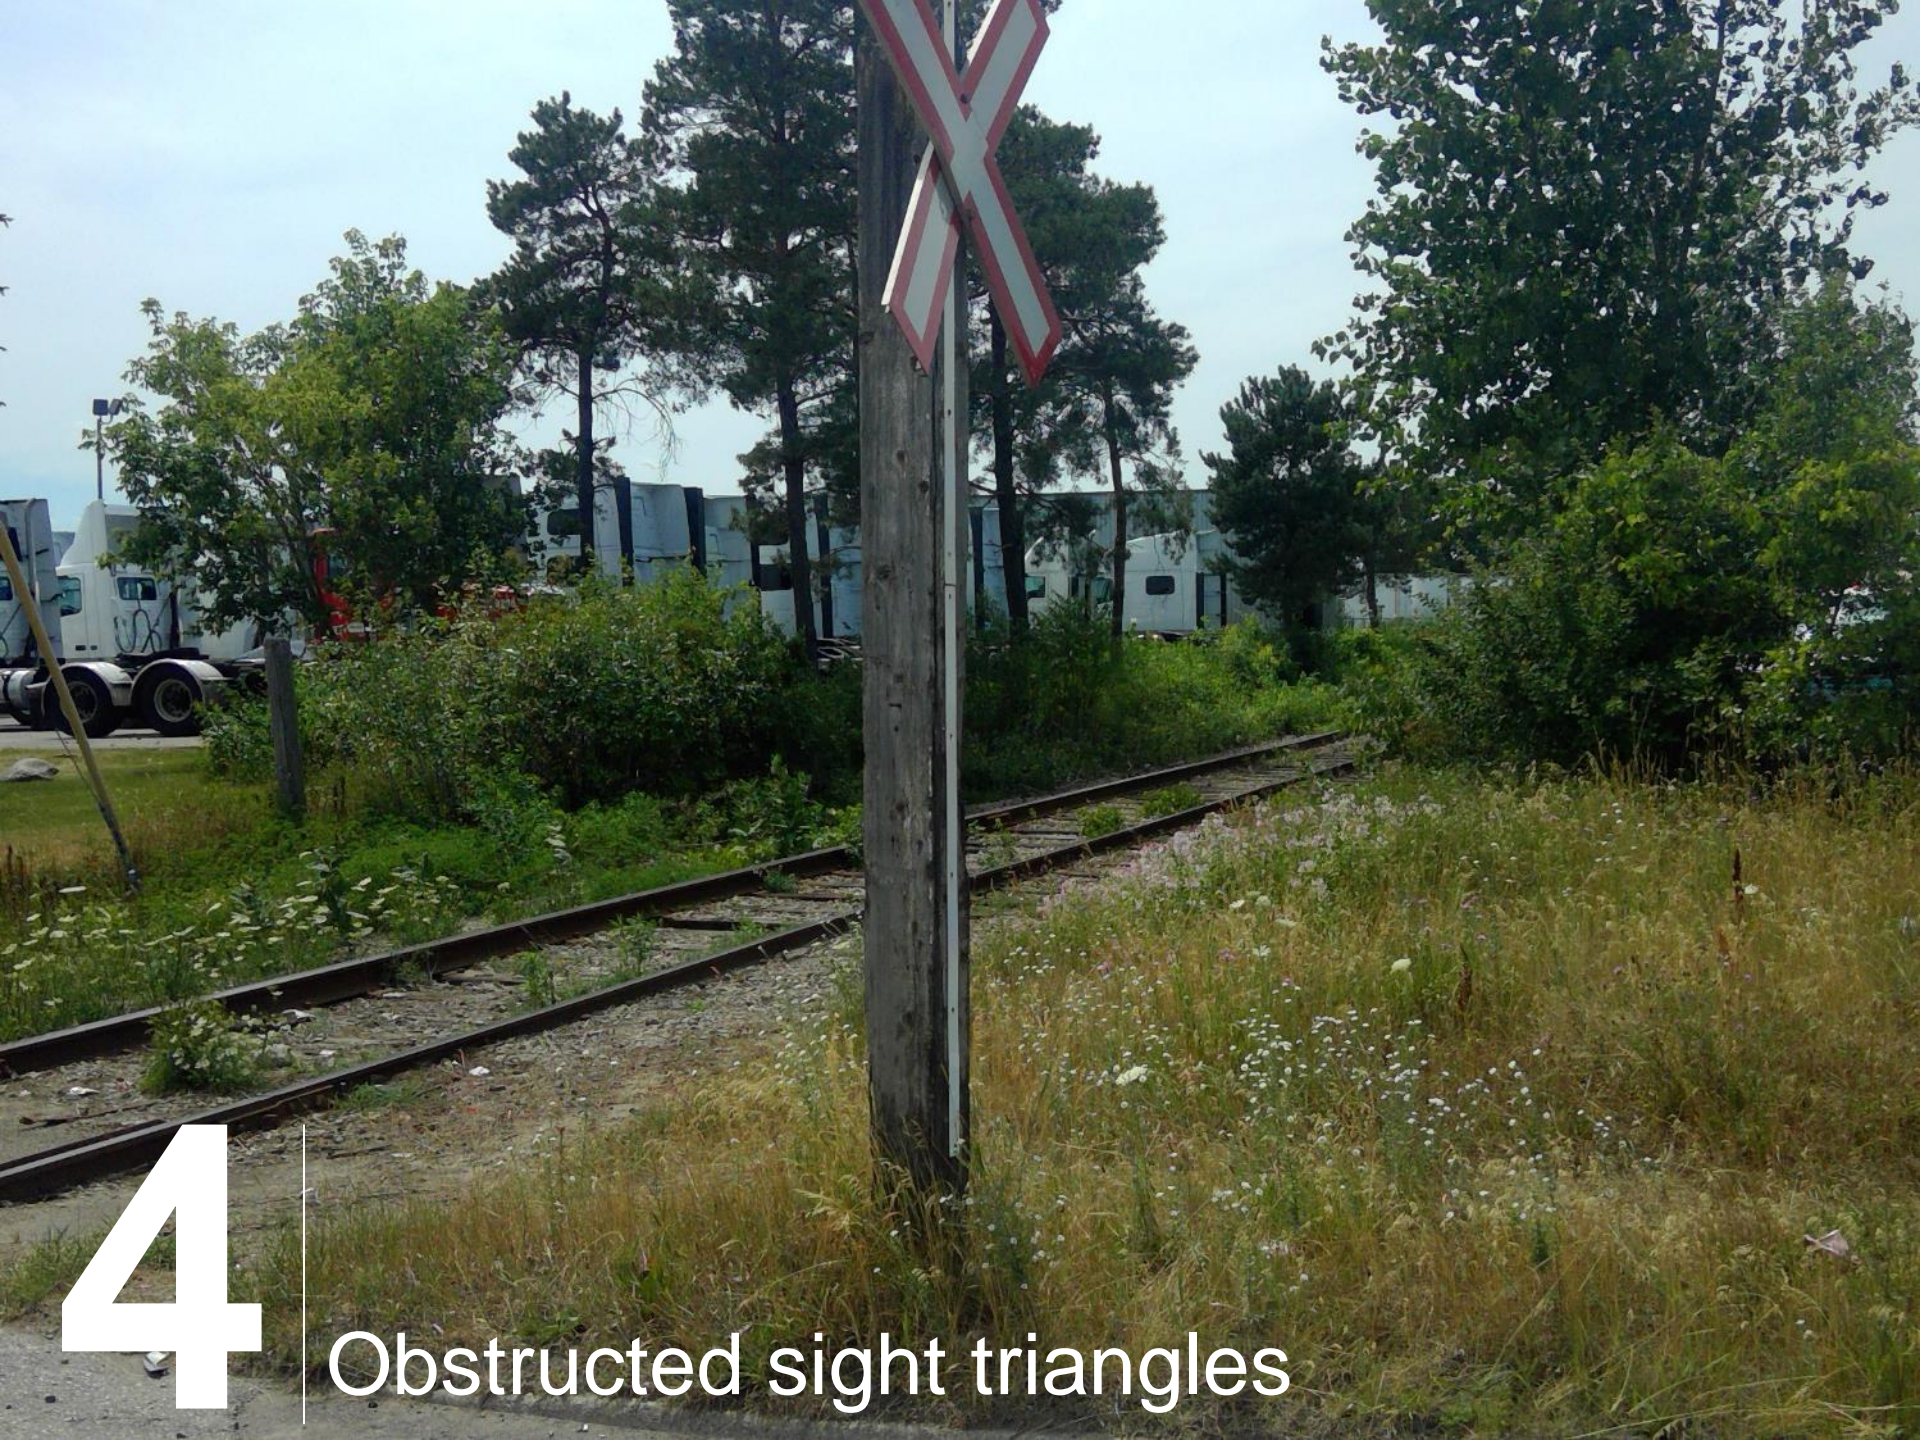
Obstructed sight triangles

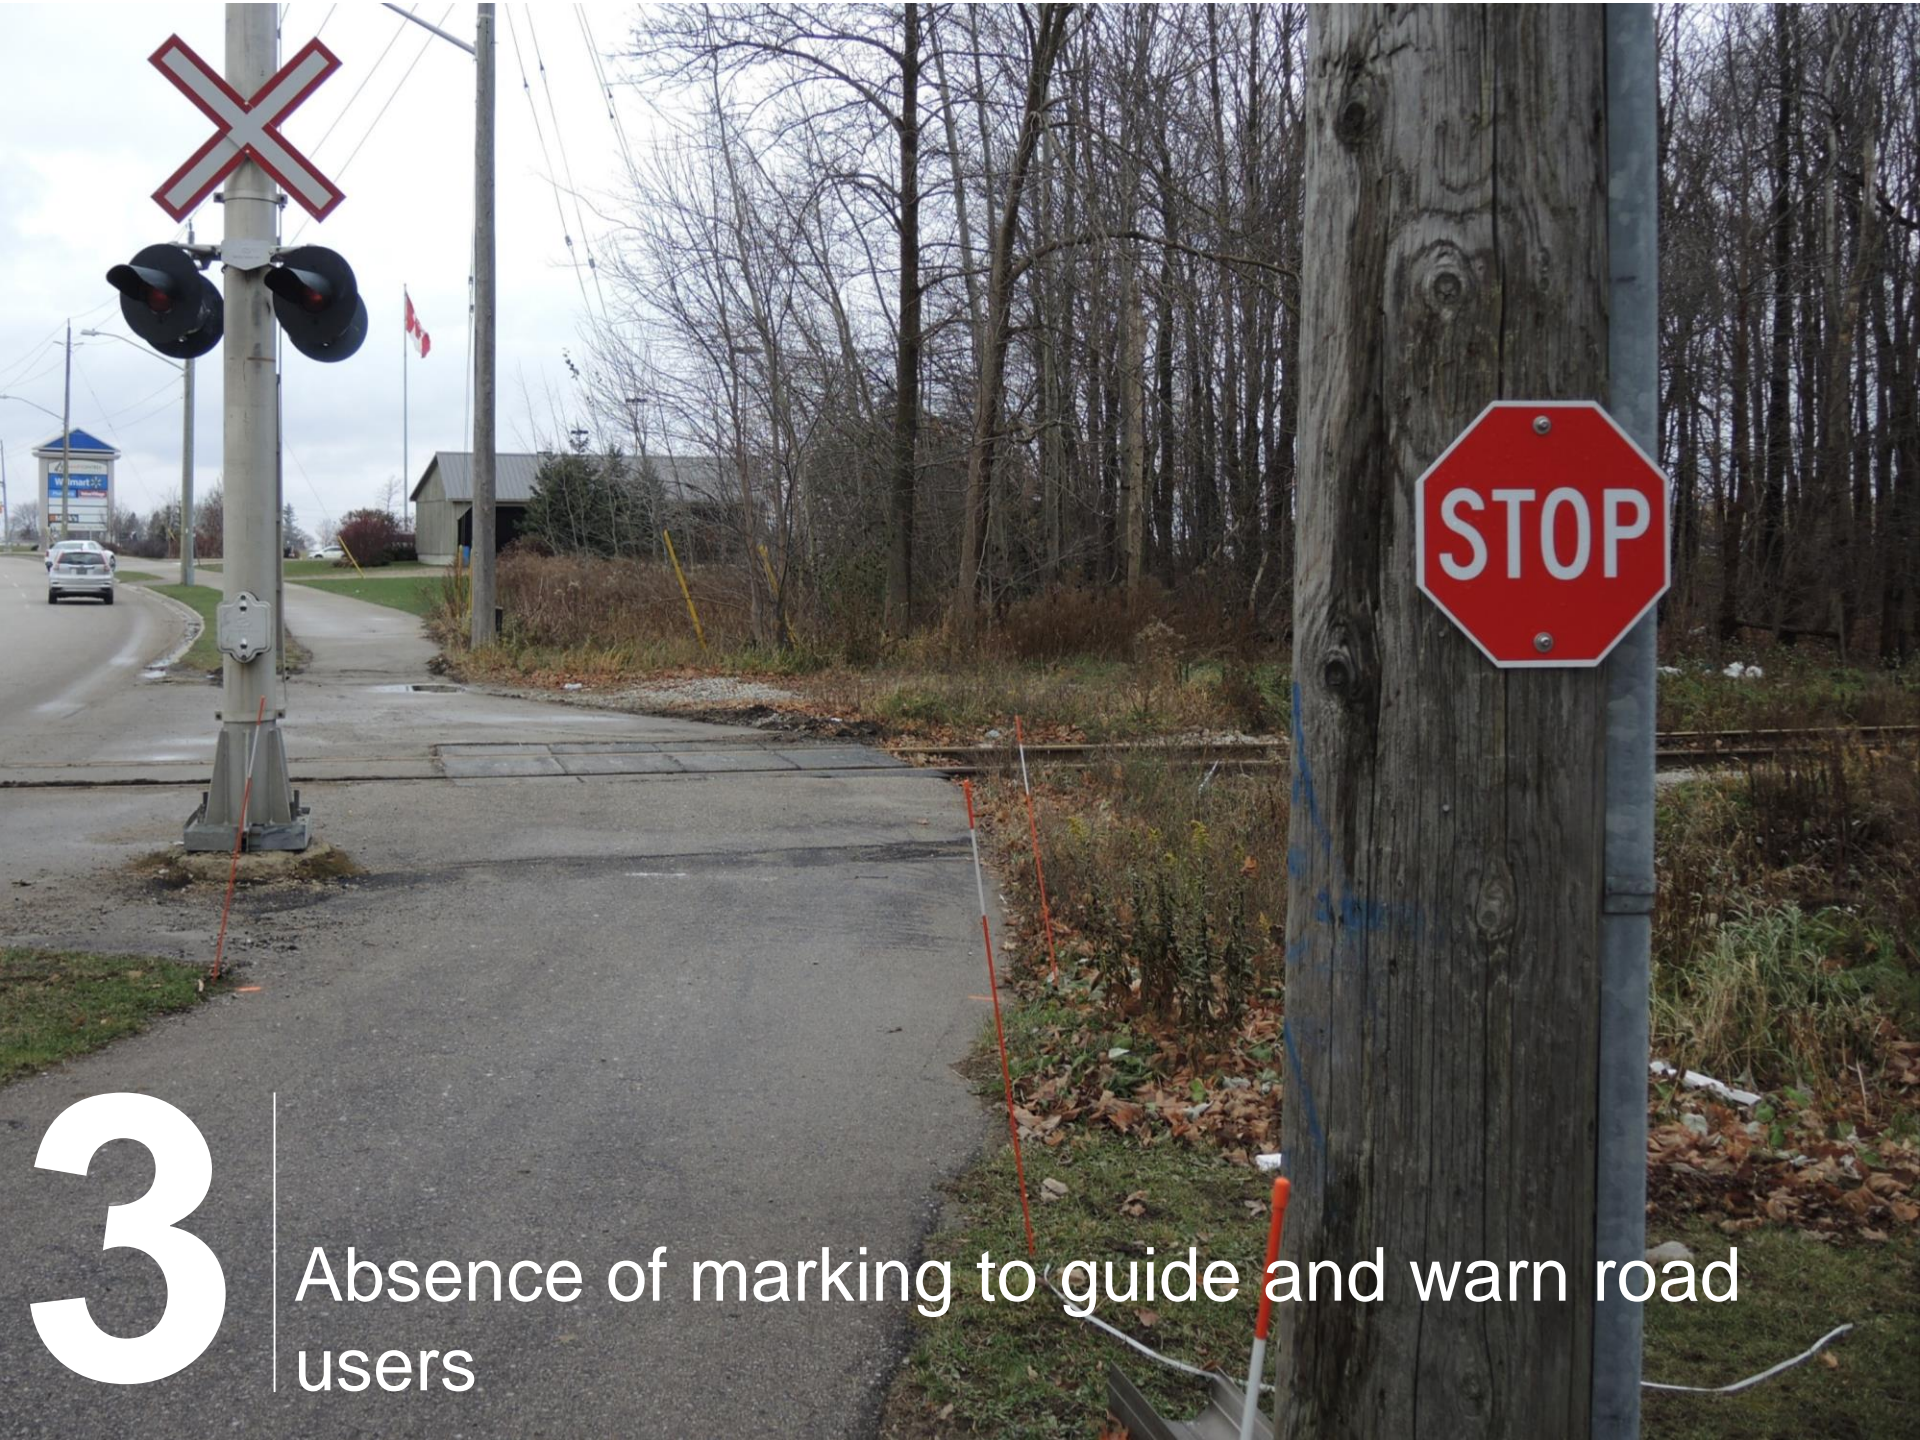
Absence of marking to guide and warn road users

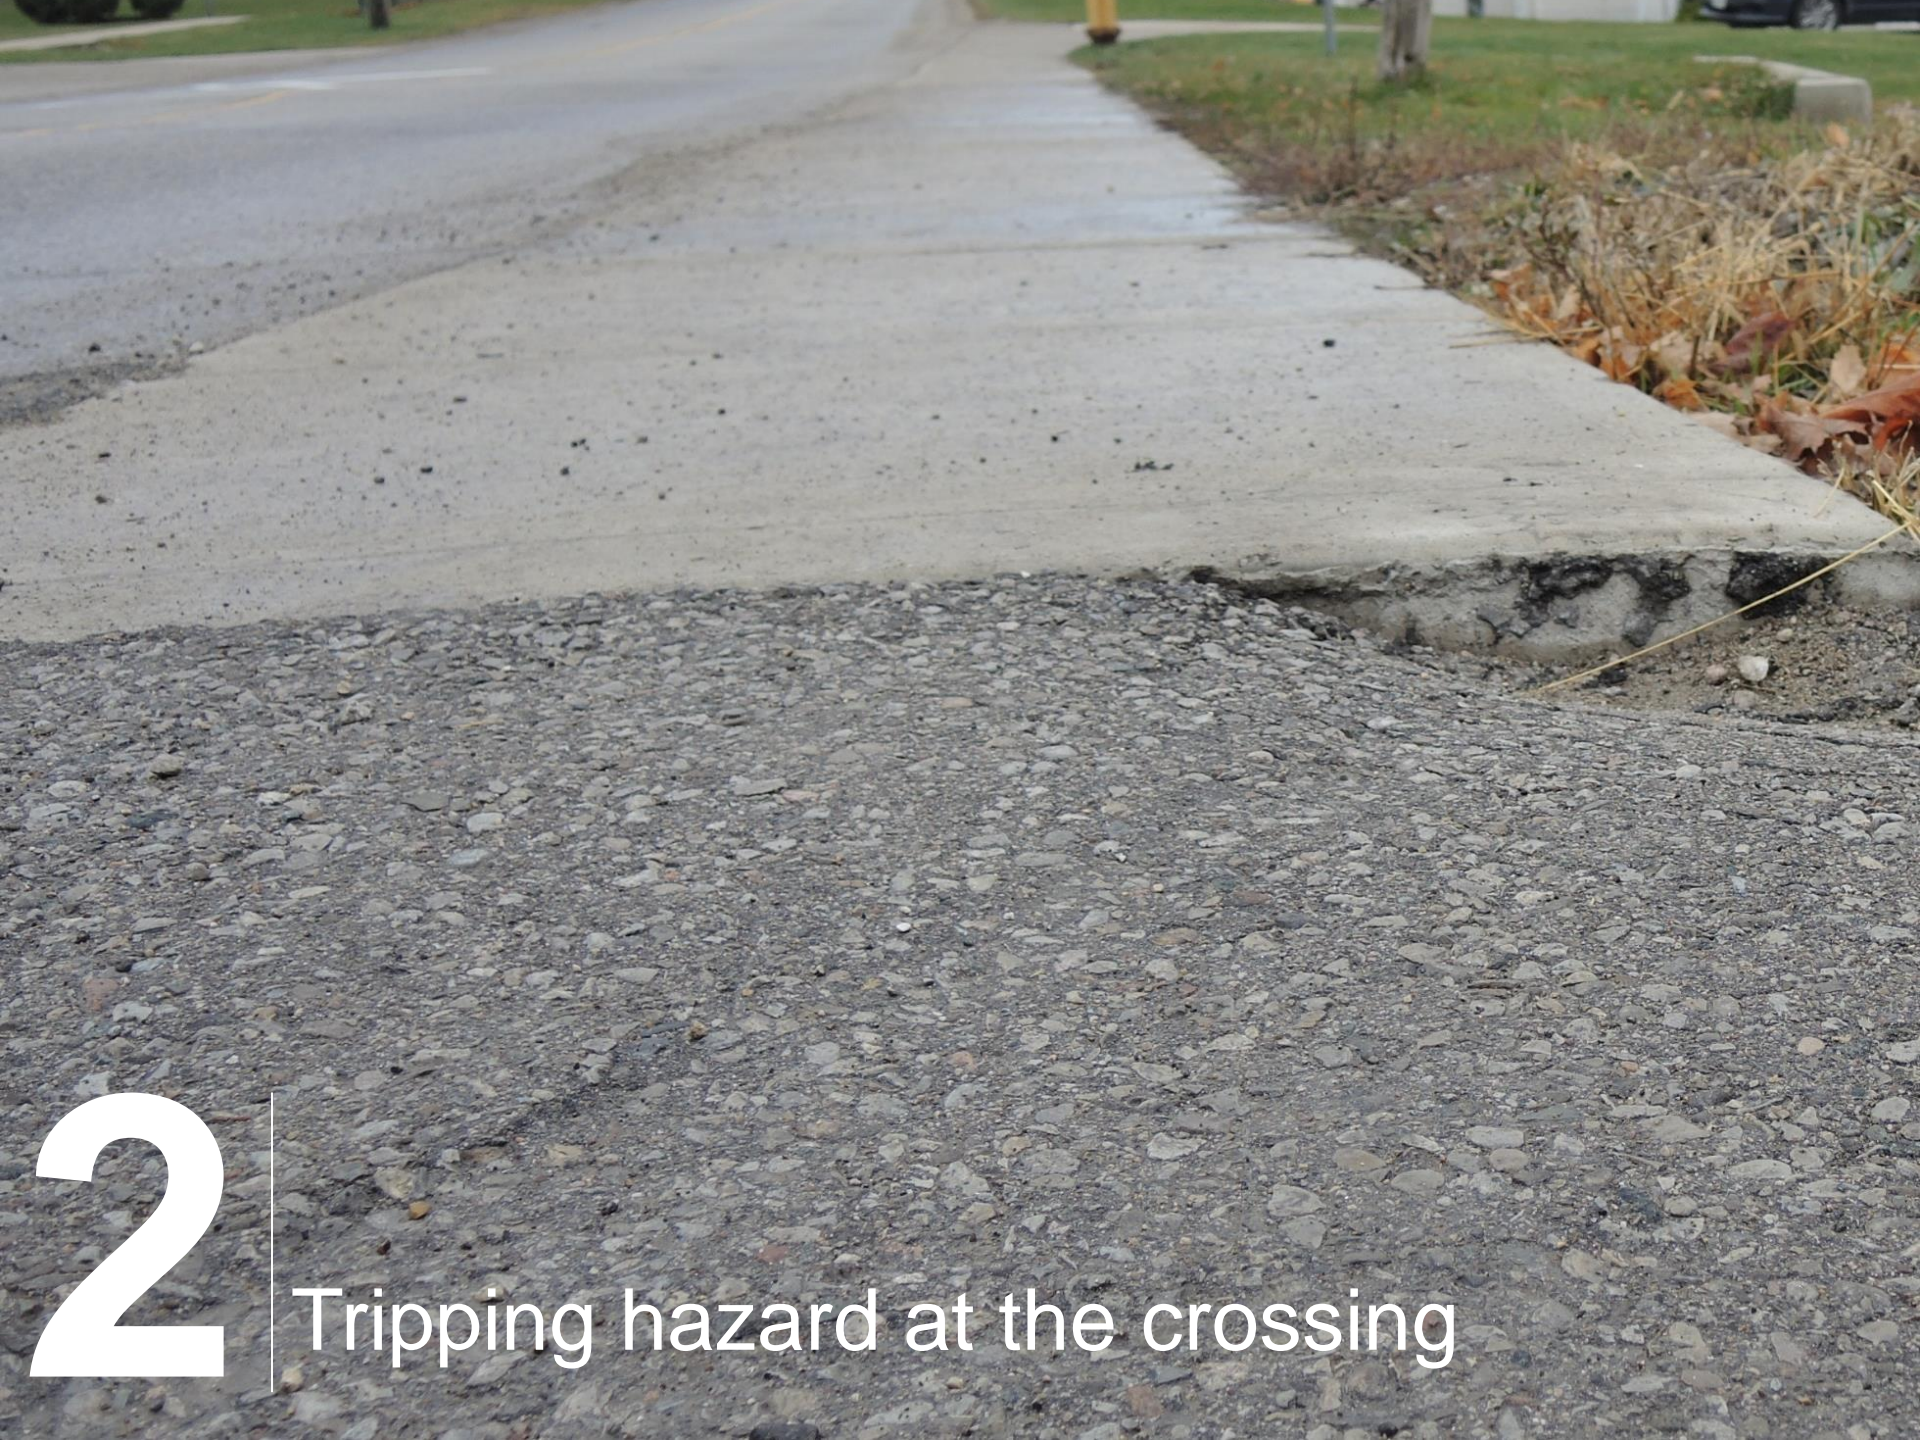
Tripping hazard at the crossing

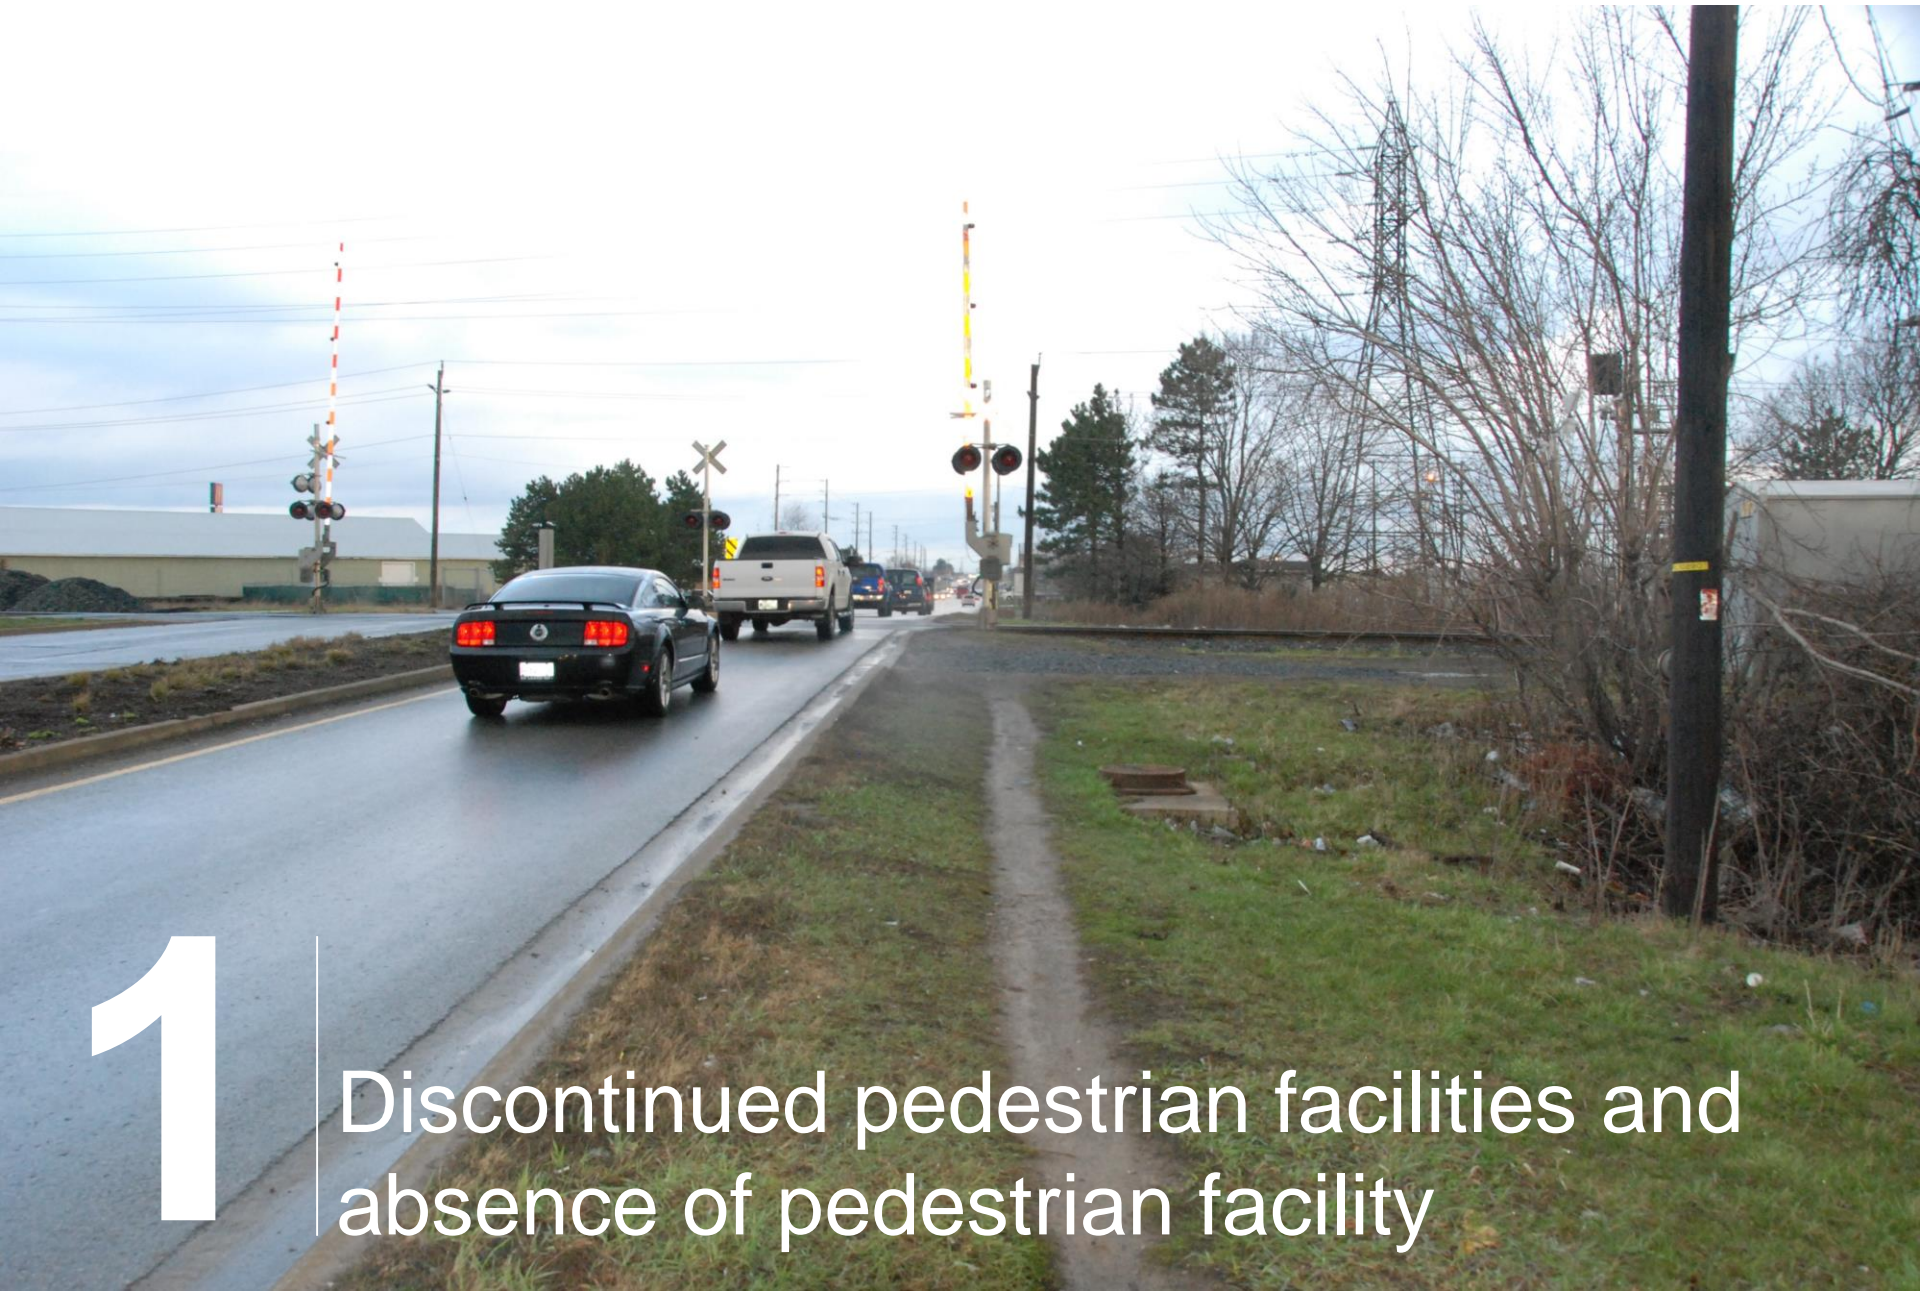
Discontinued pedestrian facilities and absence of pedestrian facility

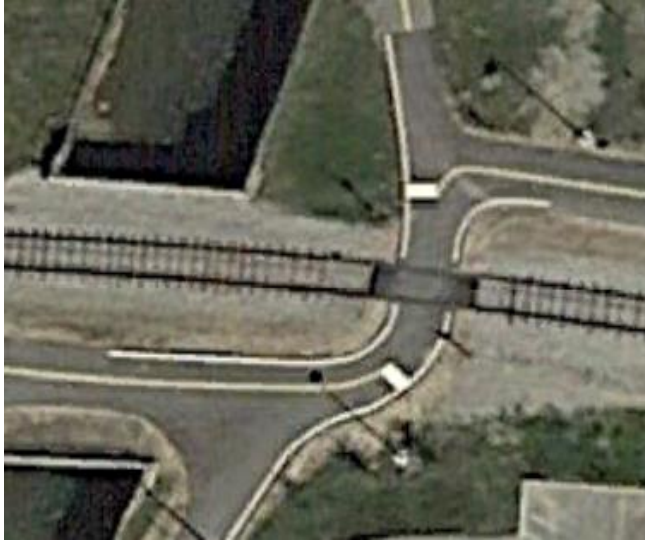
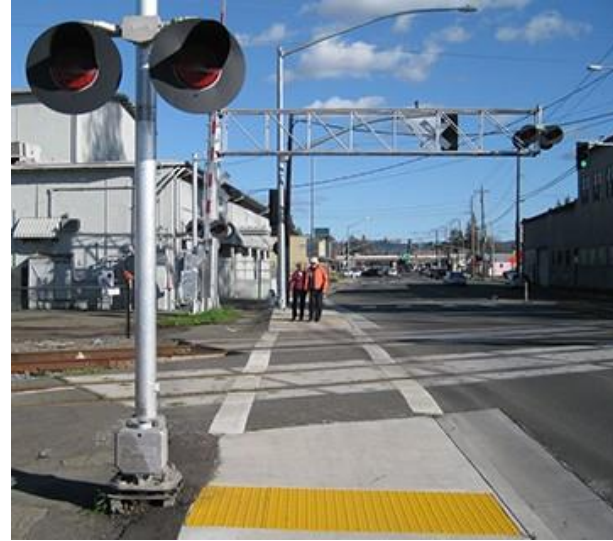
- Mark where pedestrian are to stop: stop lines are to be installed 5 m of the rail or 2 m ahead of crossing sign or warning system.
- Mark where pedestrian are to cross: delineate sidewalk, pedestrian path and crosswalk travelled surface within 8 m of the rail.
- Using colored detectable tactile tiles to increase visibility of the stop bar and provide hazard warning to those who are visually impaired

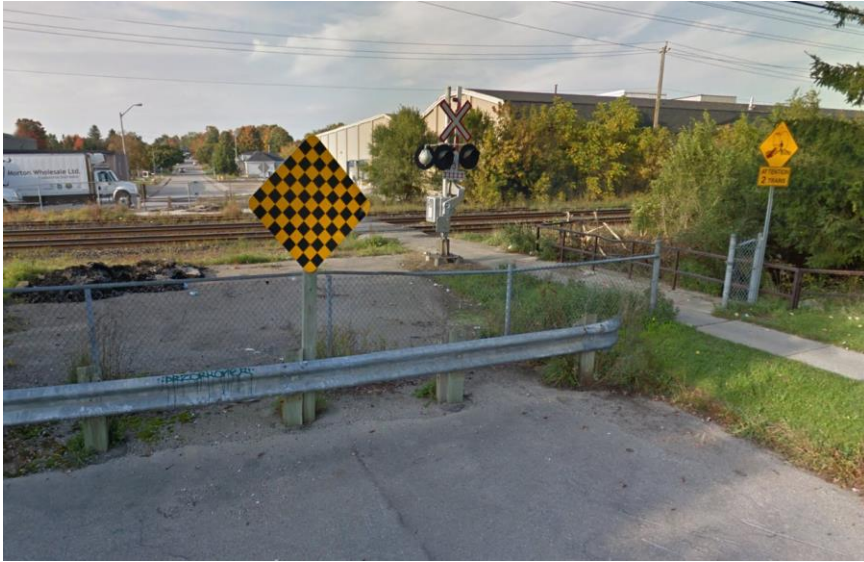
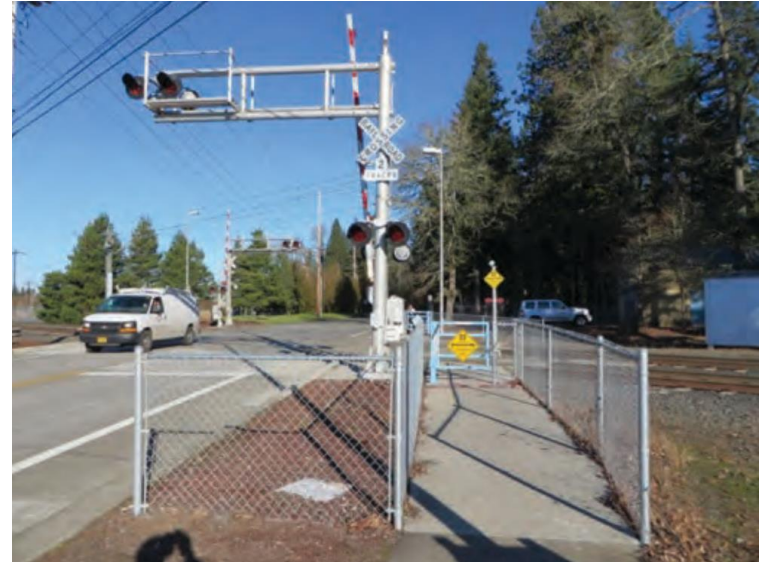
- Reduce pedestrian exposure to railway right-of-way
- Channel pedestrians along pathway/sidewalk
- Prevent short-cutting, or running around gates

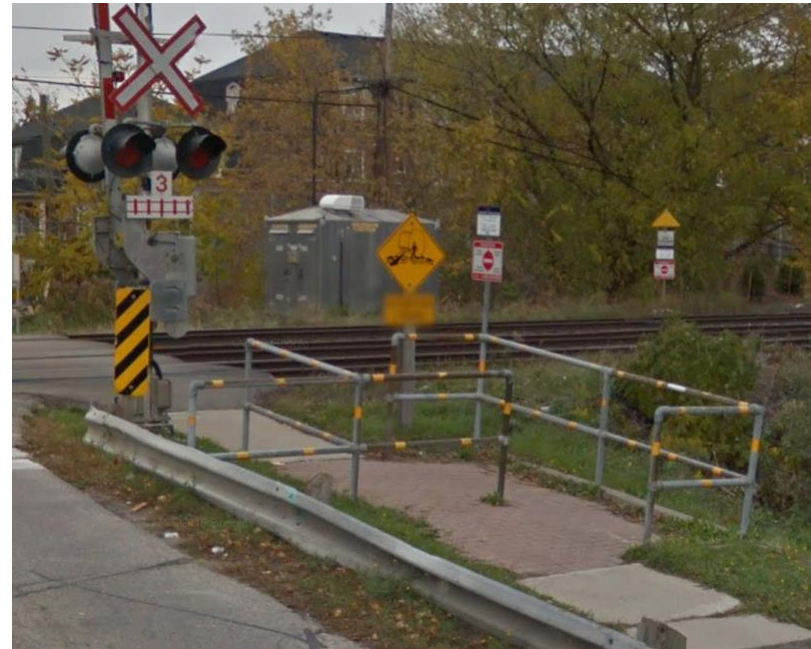
Maze fencing

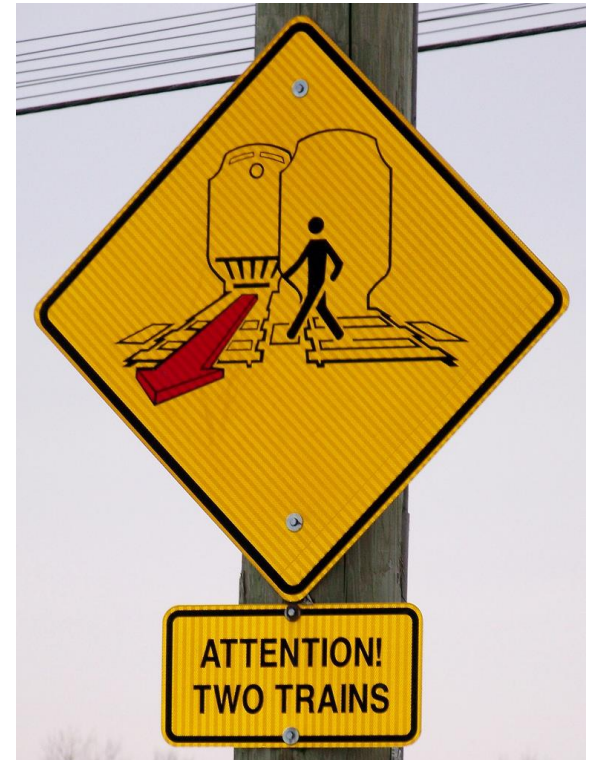
- Indicate “Stop here when lights are flashing”
- Warn of the possibility of second train events
- Indicate “Look both ways for trains”

Second Train Warning Sign

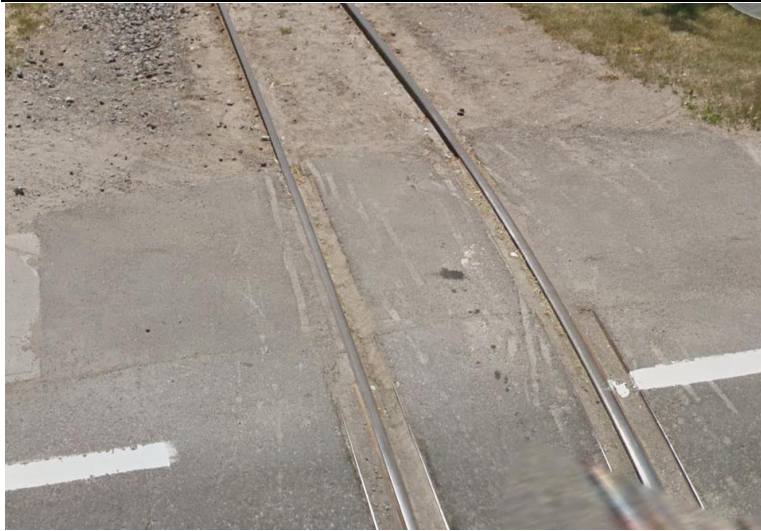
- Flangeway gaps pose a potential hazard to pedestrians who use wheelchairs, especially when the crossing is not at 90 degrees.
- Flangeway width:
 - Minimum: 65 mm
 - Maximum for when identified as an accessibility route: 75 mm
 - Typical width: 120 mm

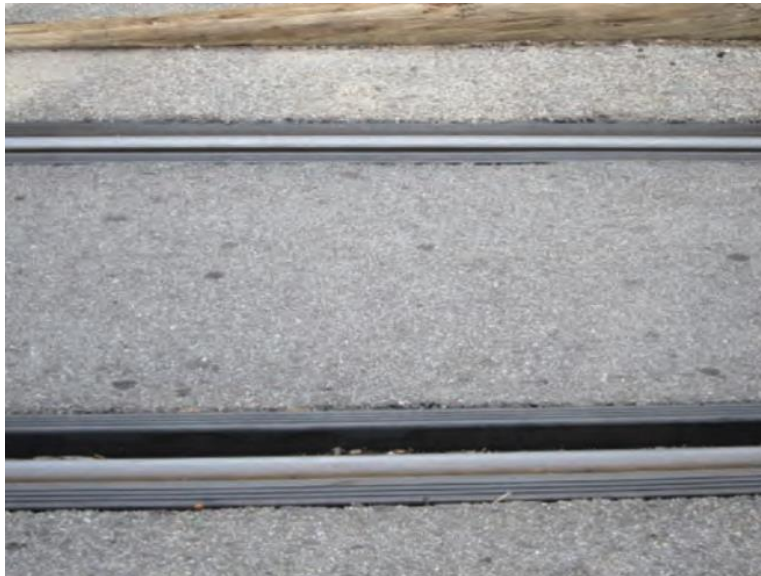
(TCRP 175, 2015)

Rubber flangeway filer used to minimize the gaps at a rail.

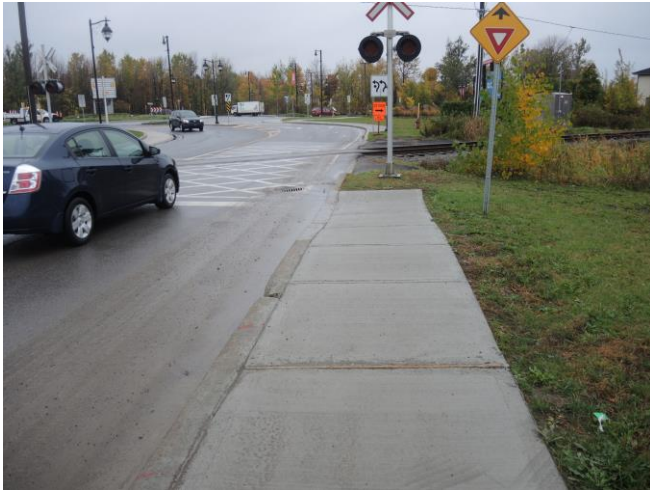
(TCRP 175, 2015)

- May be required to install treatments
- Provide a better angle of crossing when the rail tracks are at a skew to the sidewalk
- Be conscious of the potential hazard that the gate arms may represent

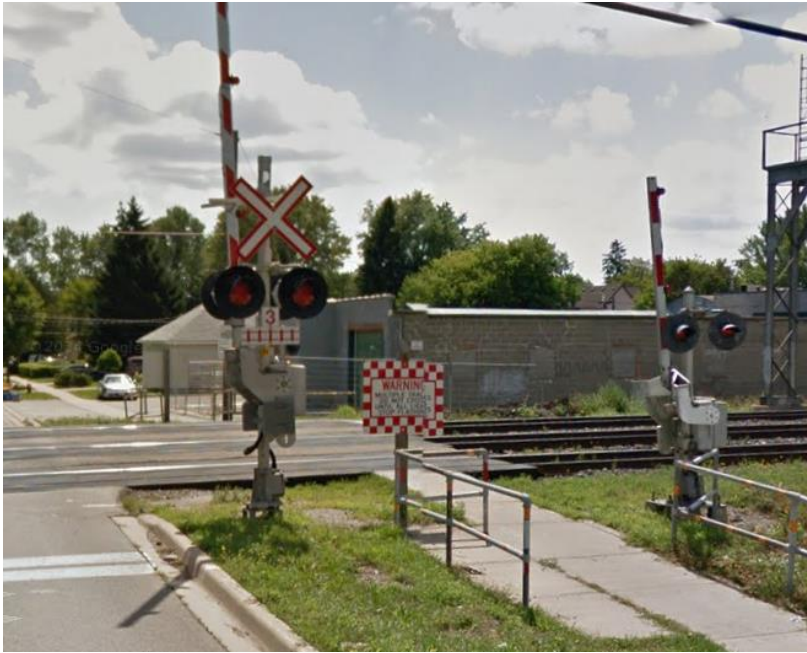
Flashing lights and a gate

- At high pedestrian and train traffic
- At crossing with more than one track
- If the offset between the centre of the sidewalk/path or trail and the road warning system is greater than 3.6 m
